Research Report

A Study and Research of Water Quality in the Learners' Community and Its Environmental Impacts

This report is part of the Earth System Science course Academic Year 2025

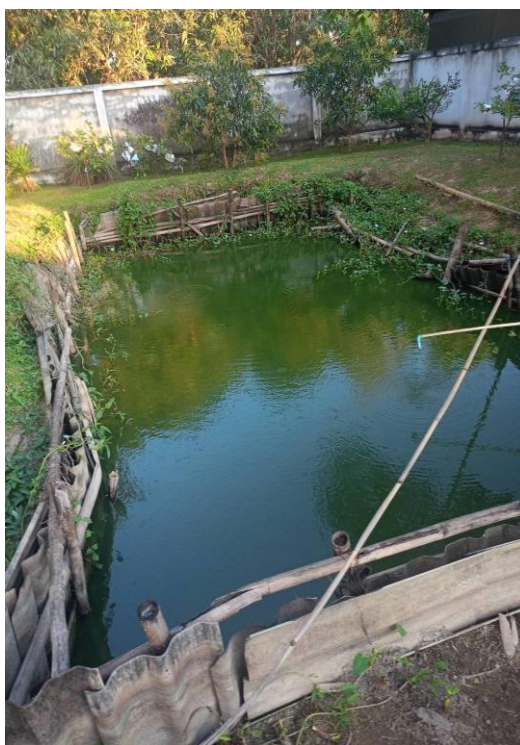
Figure 1: Water resource located at 193 Soi 14, Moo 6, San Na Meng Sub-district, San Sai District, Chiang Mai 50210.

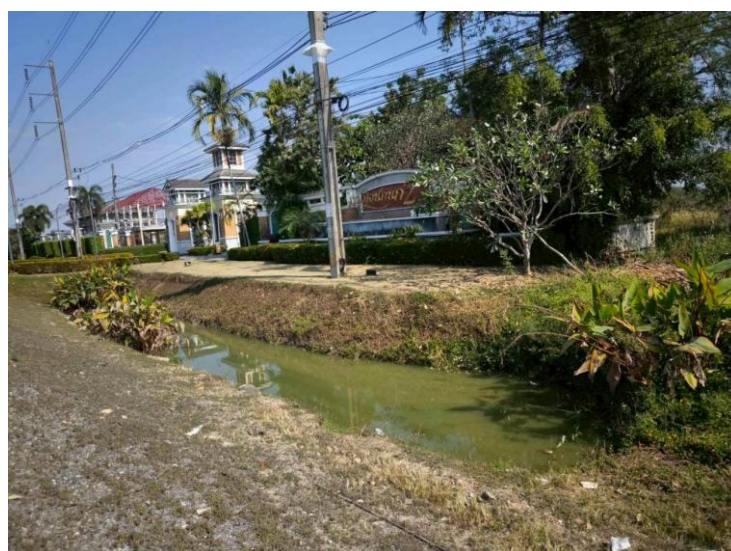
Figure 2: Water resource in front of Karnkanok 2 Village, San Pu Loei Sub-district, Doi Saket District, Chiang Mai 50220.

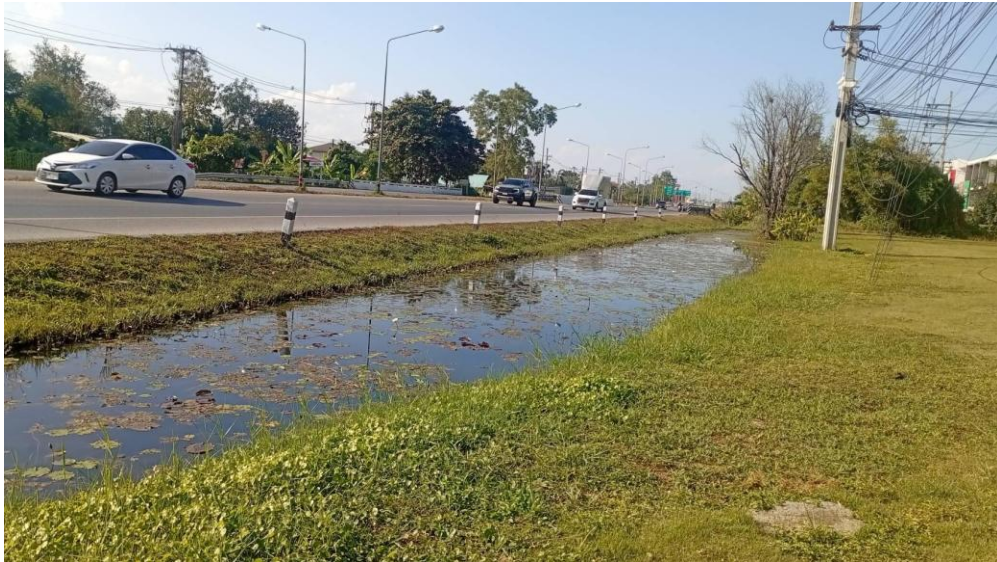
Figure 3: Water resource in front of Vararom Kaewnawarat Village, Moo 3, San Pu Loei Sub-district, Doi Saket District, Chiang Mai 50220.

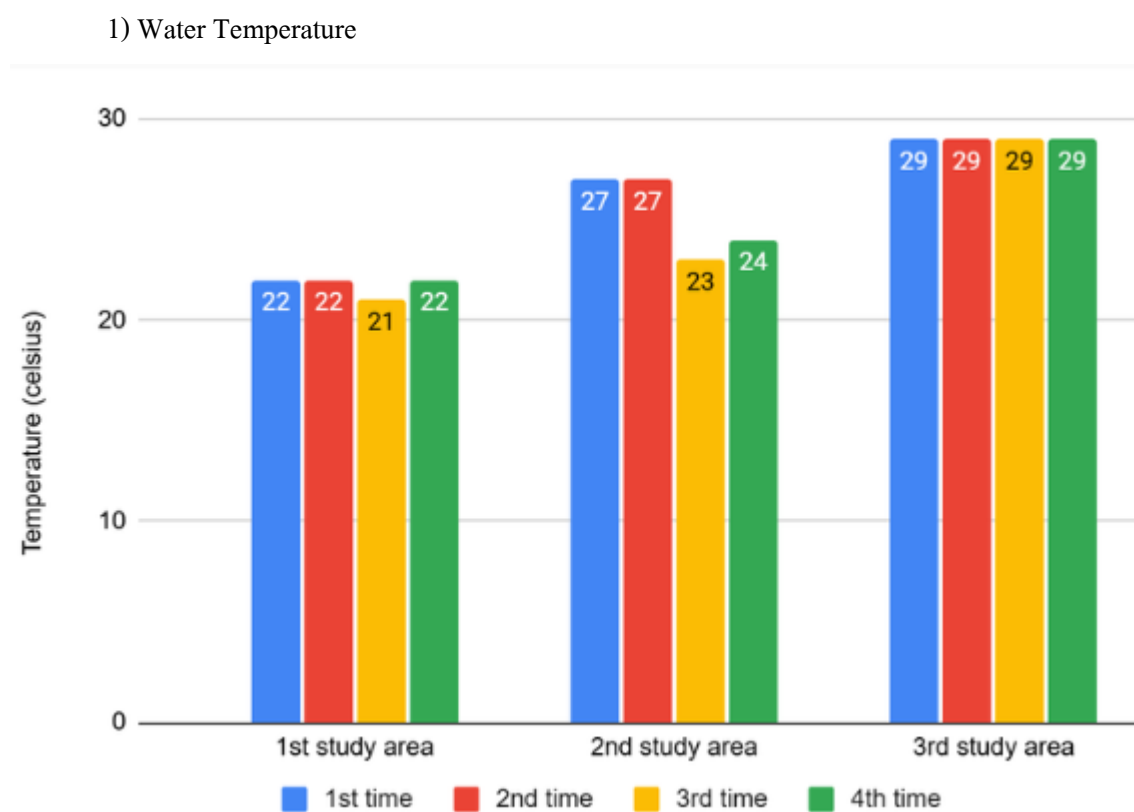
Figure 4: Comparison of water temperatures across four data collection periods at the three study sites.

As illustrated in Figure 4, water temperatures varied among the three study sites. Site 1 exhibited the lowest and most stable temperatures, consistently measuring at 22°C, with a slight decrease to 21°C during the third collection. In contrast, Site 2 showed significant thermal fluctuation, peaking at 27°C in the first two sessions before declining to 23°C and 24°C in the subsequent periods; this likely reflects the influence of external factors or variations in collection times. Site 3 recorded the

highest and most consistent temperature, maintaining a steady 29°C throughout all four measurements, indicating an environment with highly stable thermal conditions.

Water Temperature: The temperature varied across the sites. Site 1 recorded the lowest temperature, while Site 3 exhibited the highest and most stable readings. These differences may be attributed to site-specific factors such as sunlight exposure, water depth, and circulation patterns. Higher temperatures can influence dissolved oxygen levels and the types of inhabiting species. For instance, the presence of mosquito larvae at Site 3 suggests stagnant water and temperatures conducive to mosquito breeding, which may pose future public health concerns for the community.

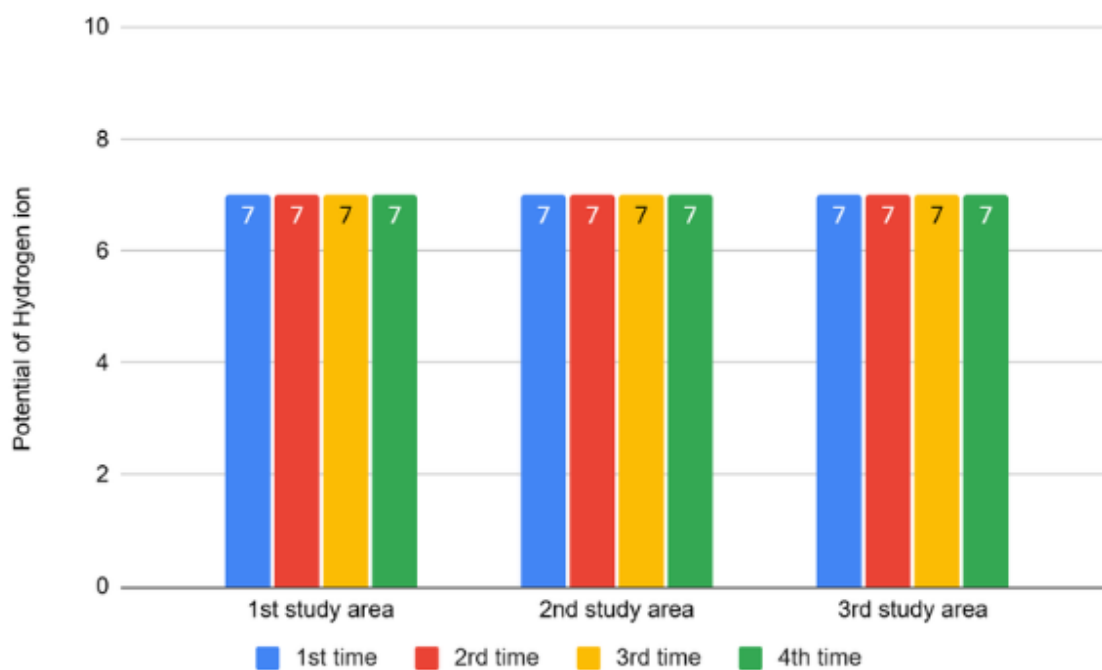
Figure 5: pH levels of water across four data collection periods at the three study sites.

According to Figure 5, the pH levels at all study sites remained constant at 7 throughout the four collection periods. This indicates that the water at every site is neutral, providing an optimal environment for most aquatic organisms.

pH Levels: The results showed that all three water sources maintained a constant pH of 7 throughout the study period. This indicates a neutral condition, which is generally suitable for the survival of aquatic organisms. Furthermore, it suggests that these water bodies have not been significantly disturbed by chemicals or waste with strong acidic or alkaline properties.
