GLOBE Estonia Learning Expedition 2025

# **INVESTIGATION OF WATERBODY PARAMETERS AT JÕULUMÄE USING GLOBE METHODS**

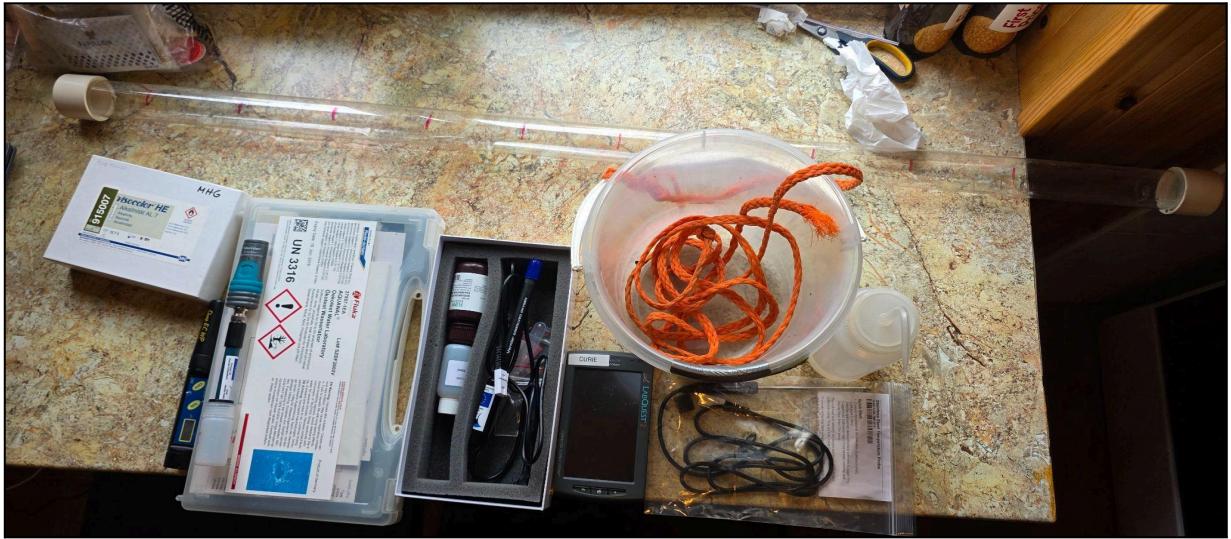
Figure 2. Tools and equipment. Photo: authors.

Our equipment consisted of bucket with rope (used to collect water), distilled water (used for cleaning and calibrating), Vernier devices for measuring water's temperature, oxygen concentration, and pH, Labquest 2 for displaying the information gathered by Vernier devices, Secchi tube (used to measure the transparency of the water), Nitrate test kit, Conductivity probe (Figure 2).

A bucket with a rope was used to collect water samples from the surface and, when possible, from slightly deeper layers of the water body. This allowed for a more representative sampling of

the pond or quarry water. Distilled water was used to clean and calibrate all measuring instruments before and after each use to ensure the accuracy of the results. Vernier sensors were connected to the LabQuest 2 device, which displayed and recorded the measured values. The Vernier temperature sensor measured water temperature, the dissolved oxygen probe measured oxygen concentration in milligrams per liter (mg/L), and the pH sensor measured the acidity or alkalinity of the water on a scale from 0 to 14. Water transparency was determined using a Secchi tube, which has a black-and-white pattern on the bottom and a graduated scale along its side. The transparency was read in centimeters (m) as the depth at which the pattern was no longer visible. Nitrate concentration was assessed using a nitrate test kit, which provided an estimate of nitrate levels in milligrams per liter (mg/L) through a color comparison on a scale: 0,1,3,5,10,20,30,50,70,90,120 (Appendix 5). Conductivity was measured with a conductivity probe, which expressed the water's ability to conduct electrical current in microsiemens per centimeter ( $\mu\text{S}/\text{cm}$ ). This parameter is often linked to the concentration of dissolved salts and ions in the water.

In general, the method involved collecting water samples from each study site, calibrating the sensors, and directly recording physical and chemical parameters in the field using the LabQuest 2 device. Each measurement was repeated several times to ensure reliability, and the instruments were rinsed with distilled water between uses to prevent contamination.

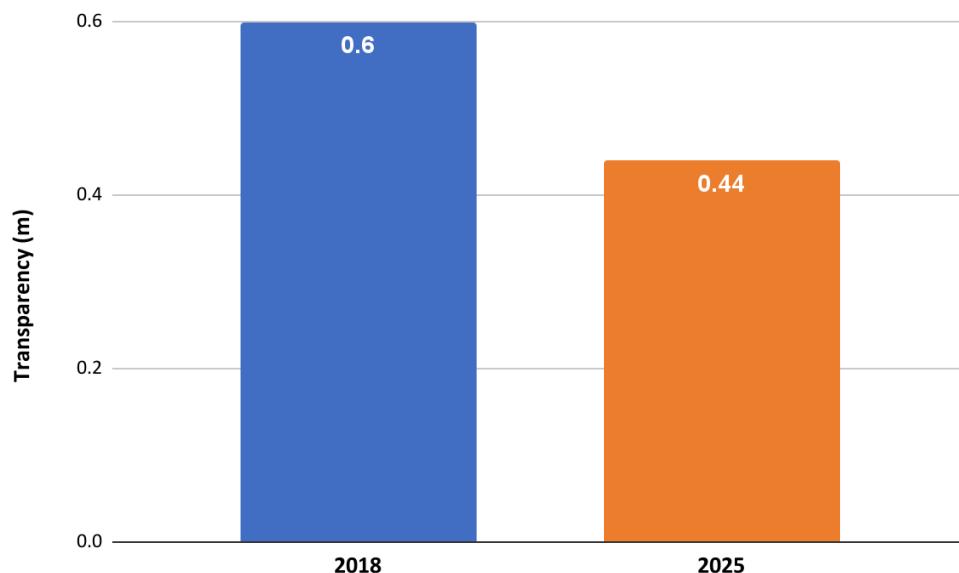
Figure 6. Transparency of the water of the quarry, in 2018 and 2025.

Hypothesis 1 predicted that water transparency would decrease over time. The transparency of the quarry water decreased from 0.60 m in 2018 to 0.44 m in 2025 (Figure 6). This supports the prediction that clarity would decline with time. The reduction in visibility appears not to be primarily algae-driven, as in the pond, but rather related to sand particles stirred up by strong winds commonly reported in Western Estonia.

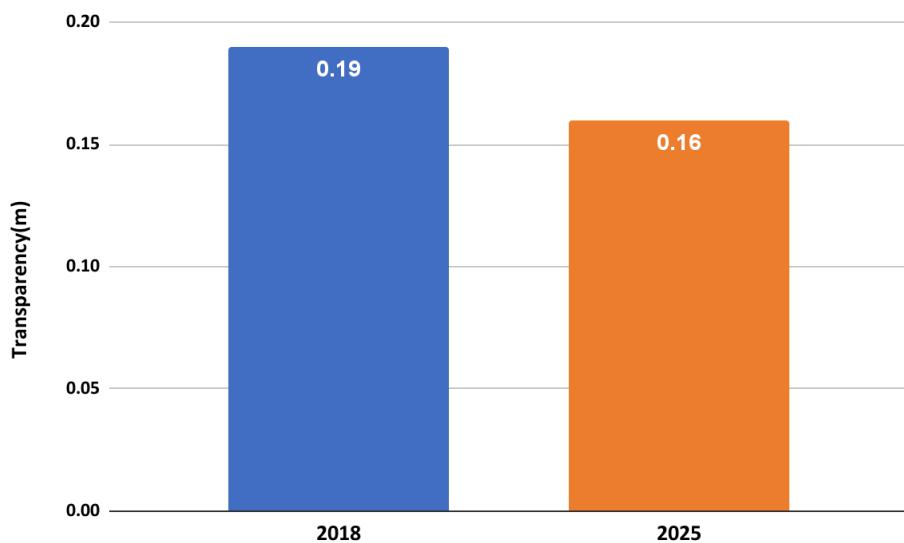
Figure 10. Transparency in the pond, in 2018 and 2025.

Hypothesis 1 suggested that water transparency would decline. The pond's transparency decreased slightly from 0.19 m in 2018 to 0.16 m in 2025 (Figure 10), supporting the hypothesis. The pond water exhibited a visible green coloration, indicating heavy algal presence, which likely caused the reduced clarity.

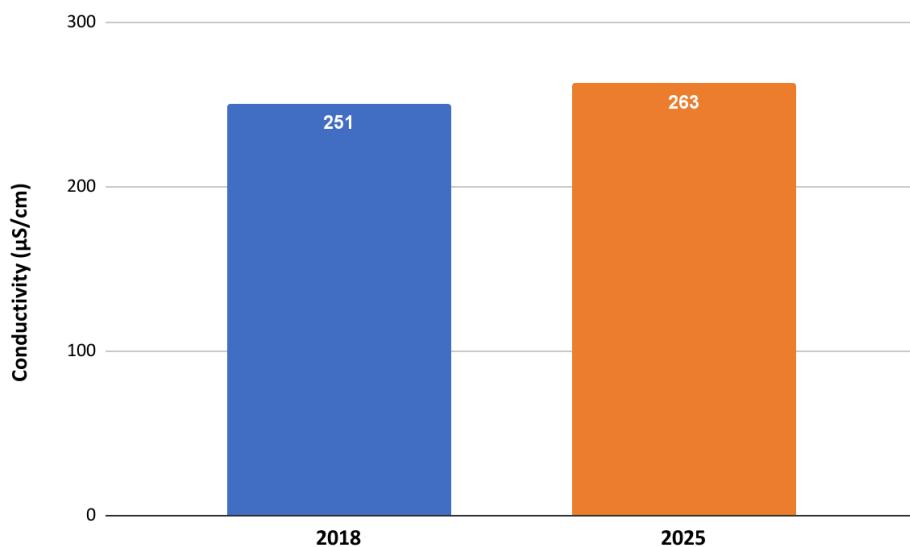
Figure 11. Conductivity in the pond, in 2018 and 2025.

Hypothesis 4 expected that conductivity would increase over time. The pond's conductivity rose from 76.3  $\mu\text{S}/\text{cm}$  in 2018 to 81.5  $\mu\text{S}/\text{cm}$  in 2025 (Figure 11), confirming this hypothesis. The increase suggests ongoing accumulation of dissolved salts due to environmental and possibly human influences.

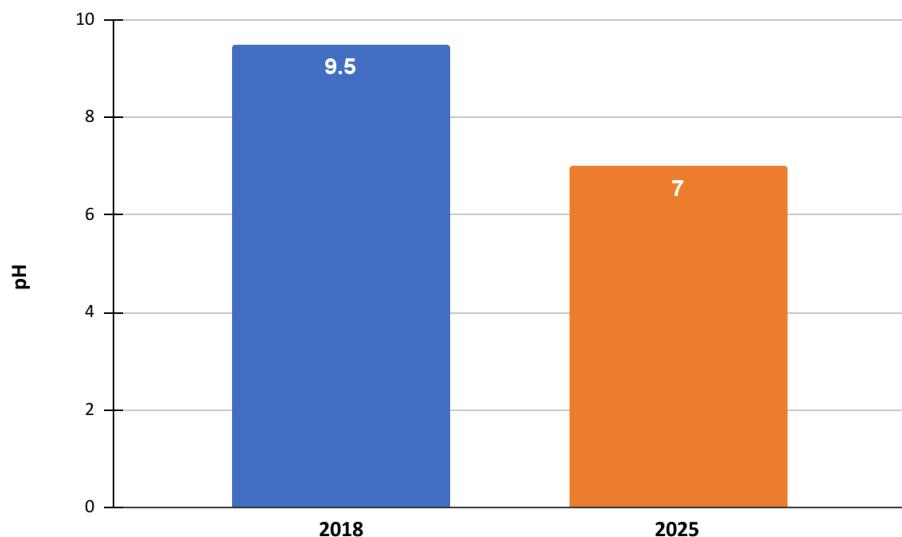
Figure 12. pH in the pond, in 2018 and 2025.

Hypothesis 2 proposed a significant drop in pH, especially in the pond. The pH decreased from 9.5 in 2018 to 7.0 in 2025 (Figure 12), confirming the strongest decrease among all three sites. The decline of 2.5 units supports the hypothesis and can be attributed both to improved measurement accuracy in 2025 (Vernier probe) and to acidic rainfall during an unusually rainy summer. Heavy storms just before sampling likely intensified this acidification.

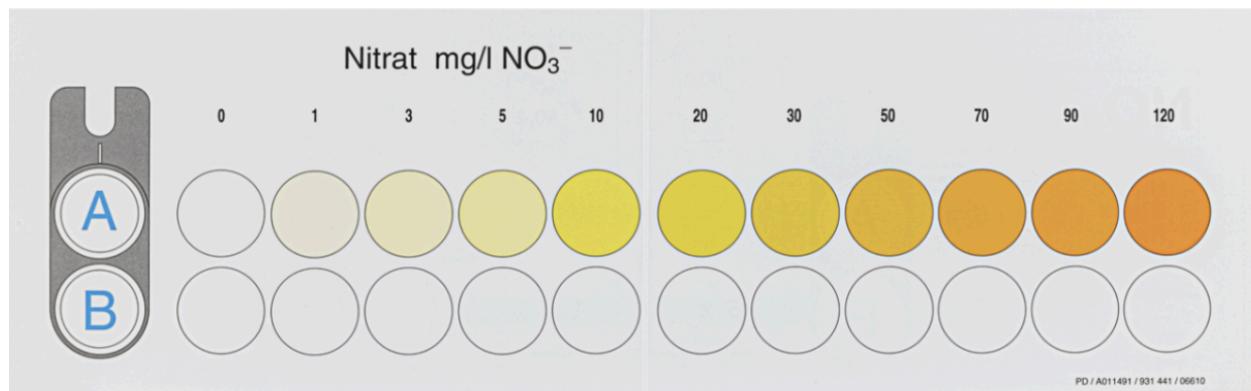
**Figure 25.** Nitrate scale from Nyos nitrate test kit.
