Comparison of Nitrates at Creamer’s Field and Sheep Creek

Research Question: How do nitrates and pH vary between agriculture and non-agriculture sites?

Thea Person & Inga Peterson
NRM 370, Kelsey Aho
Department of Natural Resources, University of Alaska Fairbanks

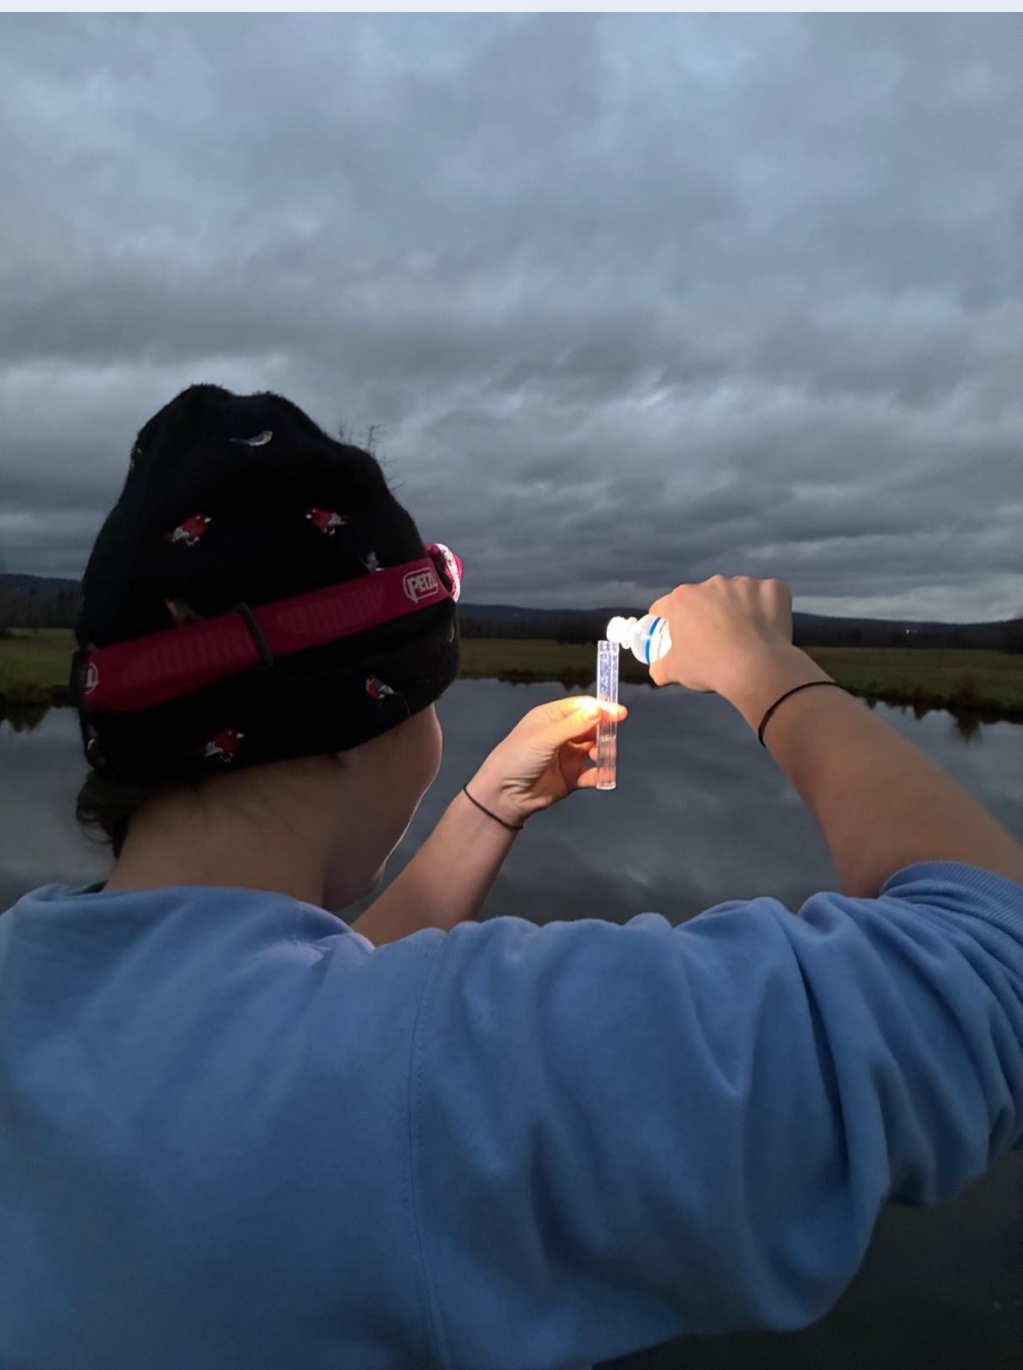
Fig. 1 Thea Person pours sample water into test tube

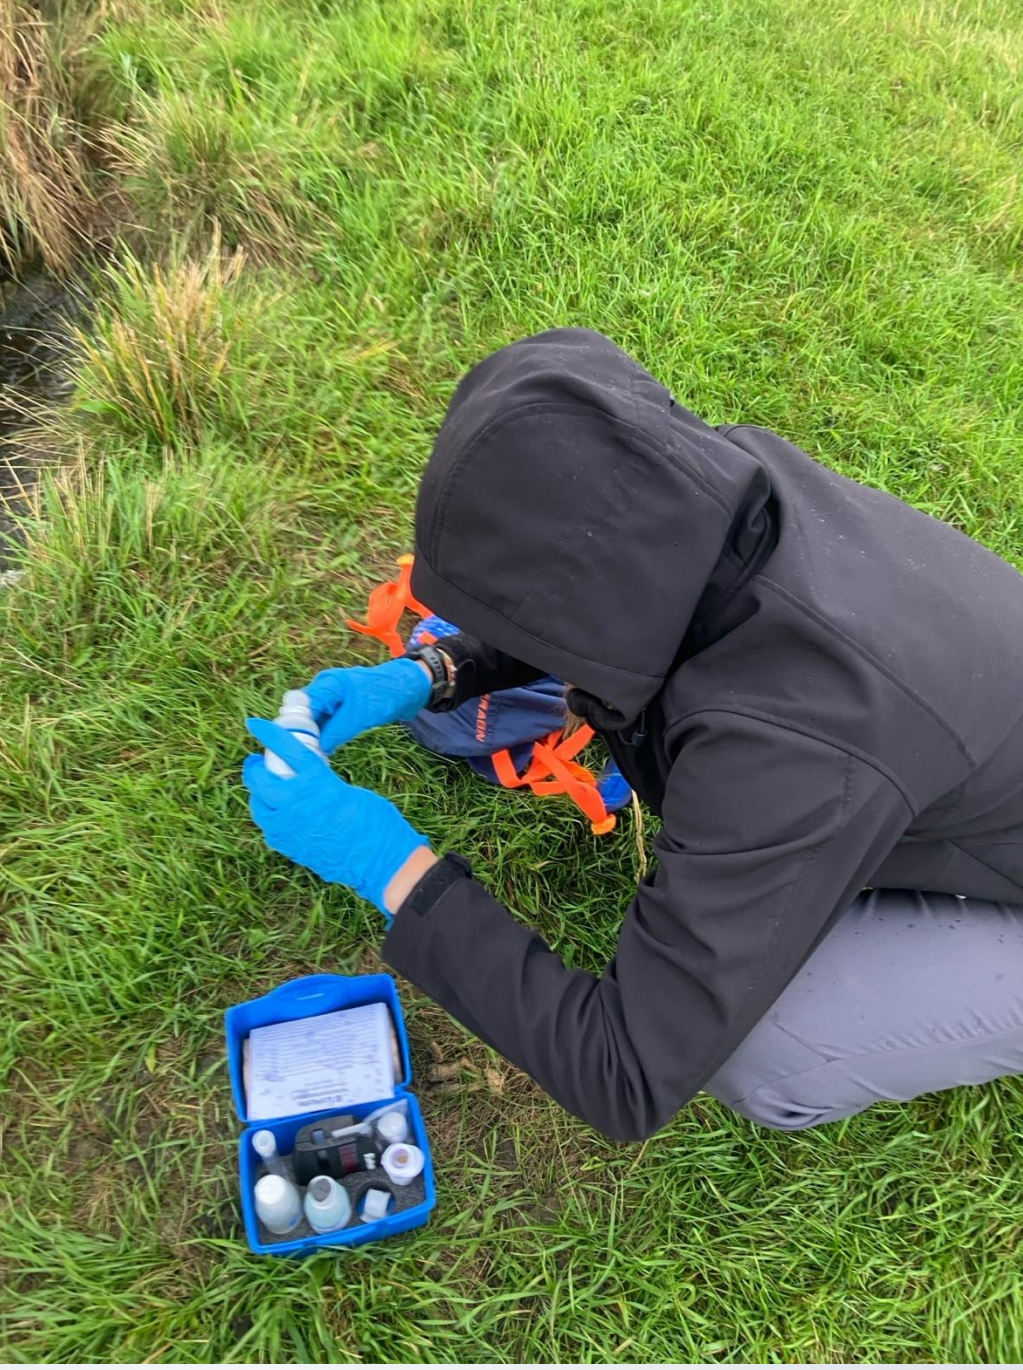
Fig. 3 Inga Peterson prepares nitrate test in the field
