GLOBE Estonia Learning Expedition

The effect of urban environment on the River Emajõgi

Tartu 2024

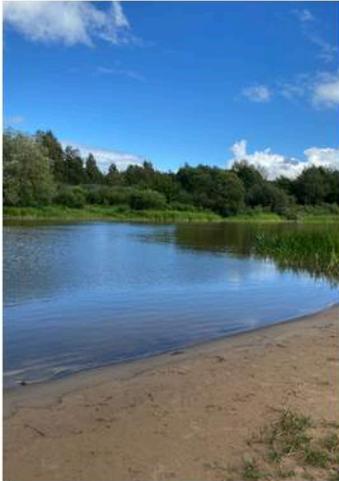
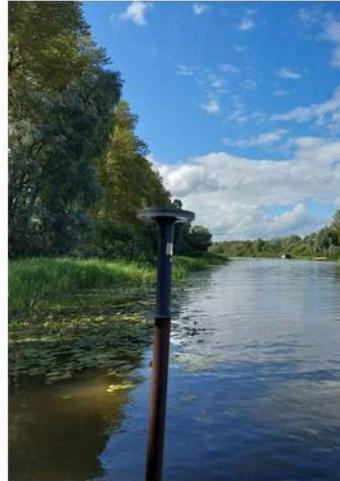
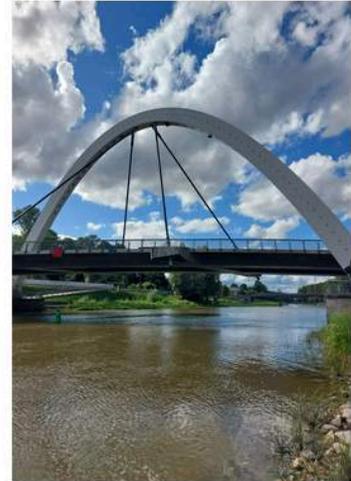
Location 1: Beach of Supilinn

Location 2: Pier

Location 3: Vabadussild

Figure 4. Research sites in photos. Location 1 is Emajõgi 1 on the map, and so forth. Photos: authors

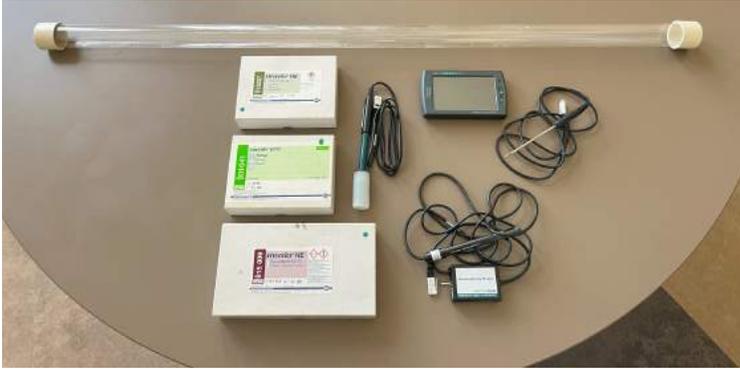
- Vernier thermometer,
- Vernier conductivity probe,
- Vernier pH probe,
- a bucket with a rope,
- transparency tube,
- chemical kits (Visocolor): oxygen, nitrate, alkalinity.

Figure 5. Equipment. Photo: authors

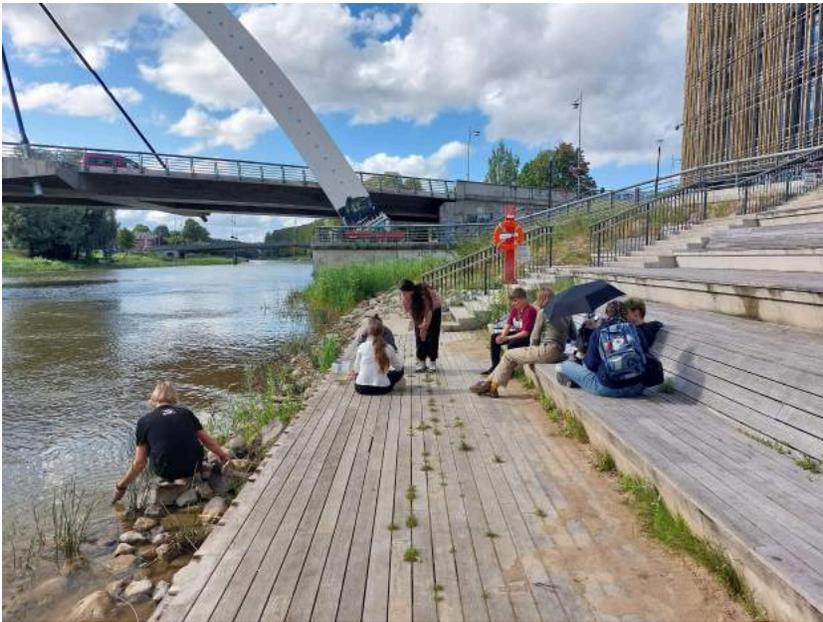
Figure 6. Collecting samples. Photos: Riin Värton

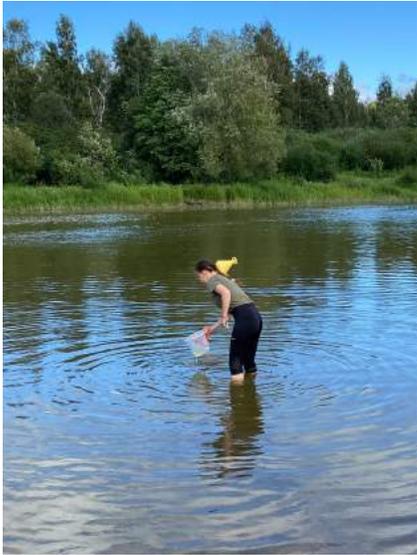
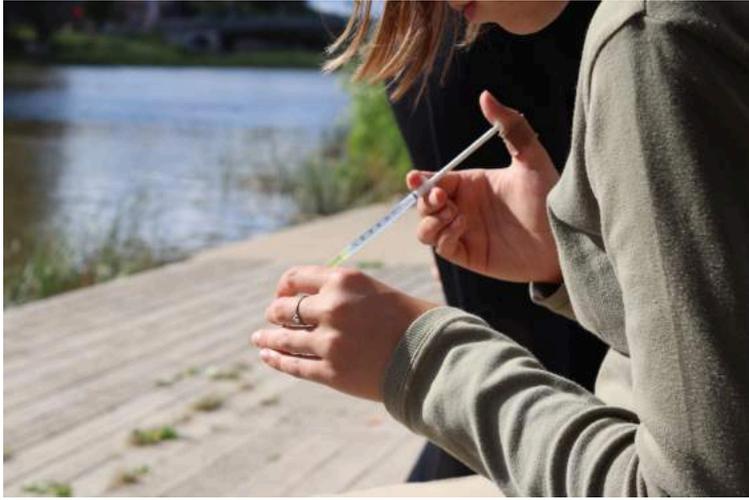
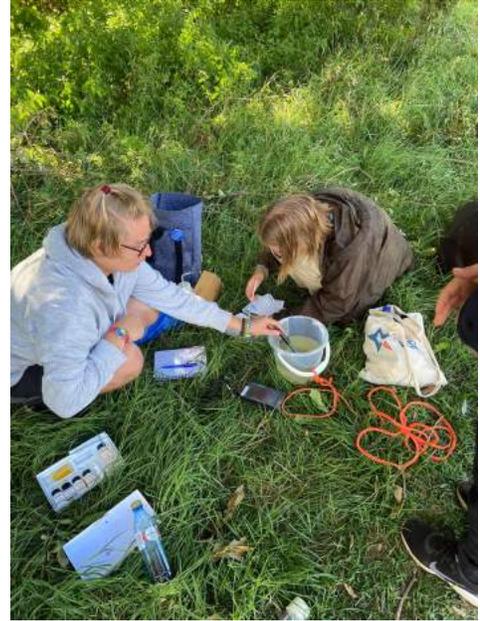
Figure 7. Collecting data, analysing samples. Photos: Riin Värton
