Relationships Between Benthos, Water Chemistry and Human Activity in Jõulumäe Trench

Abstract

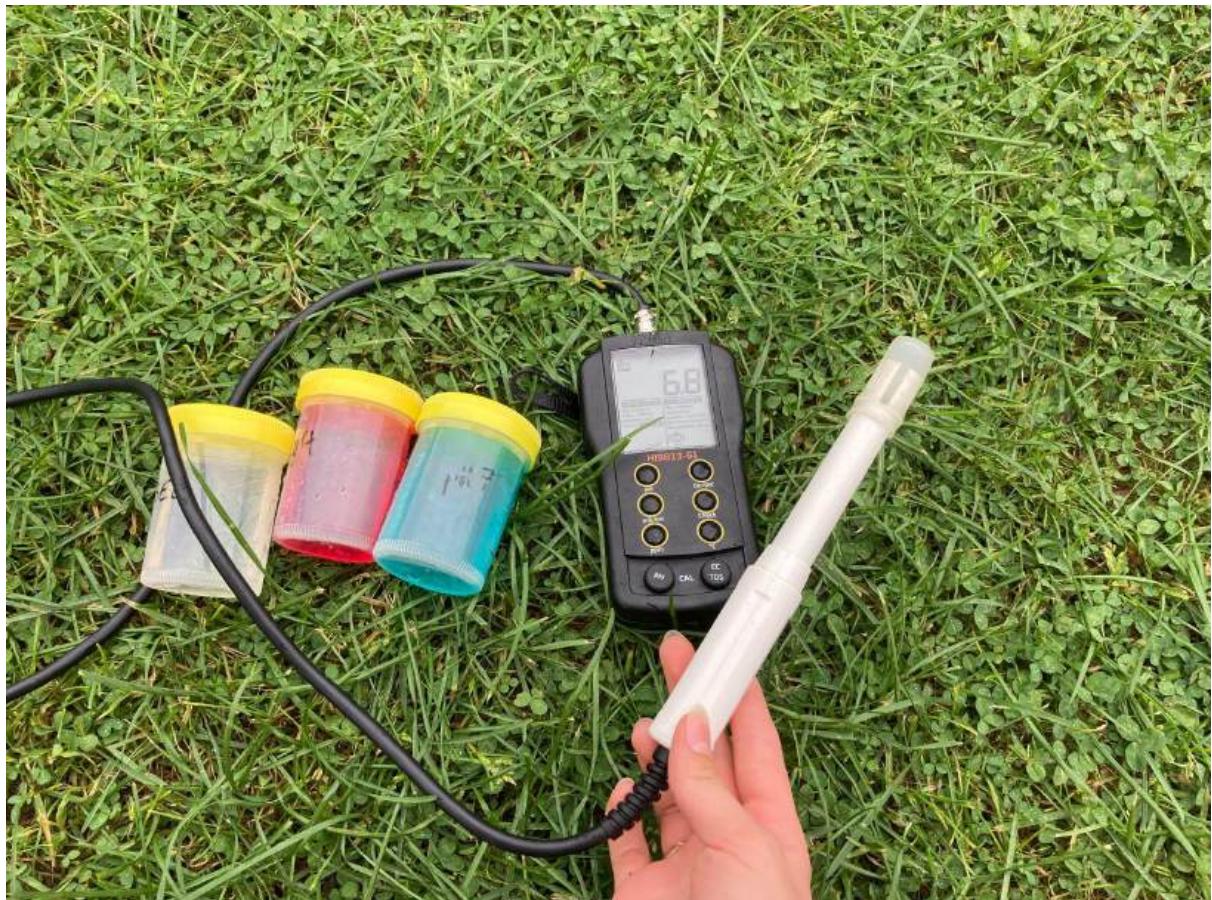
Figure 3. Multimeter and the solutions used to calibrate it (M. Loit)

For the investigation of trench water, we used the following equipment (Figure 3): a telescopic rod for collecting water samples, sampling bottles, a bucket, the Estonian Land Board's online mapping application, and a kick-net for capturing invertebrates. Water pH, electrical conductivity, and temperature were measured with a multimeter.

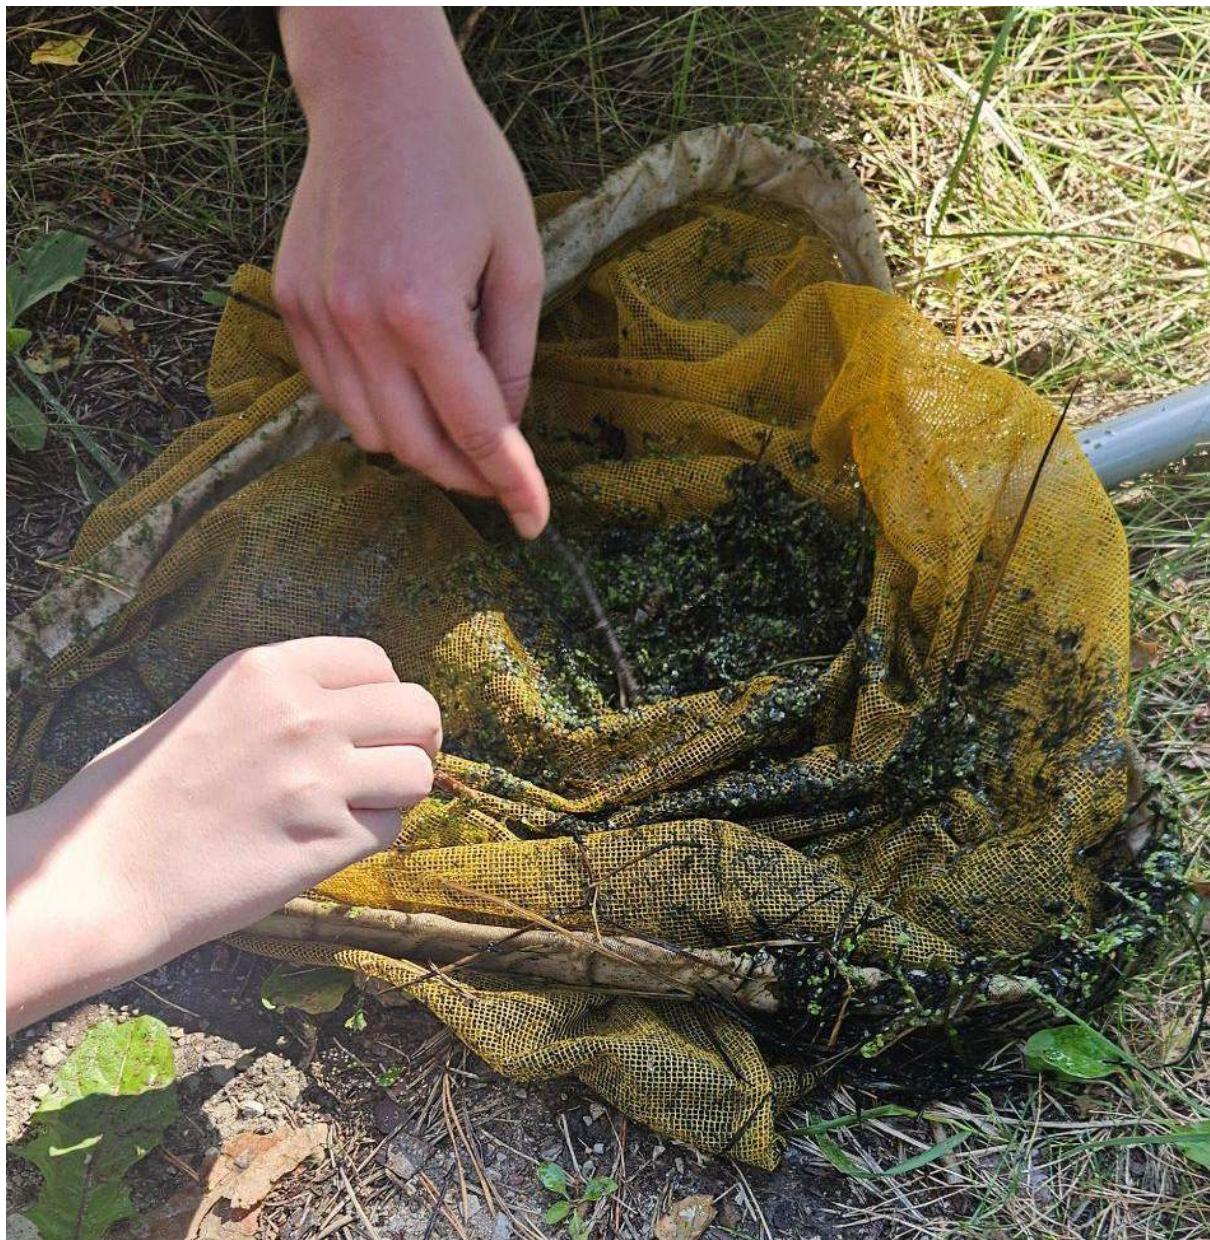
Figure 4. Looking for macroinvertebrates in a kick-net sample (A. Vaarik)

At each monitoring site, two kick-net samples were taken. After each sampling, the contents of the net were examined for two minutes to identify organisms (Figure 4). Photographs were taken of the macroinvertebrates, which were then counted and released. At each site, water pH, temperature, and electrical conductivity were measured using a multimeter.

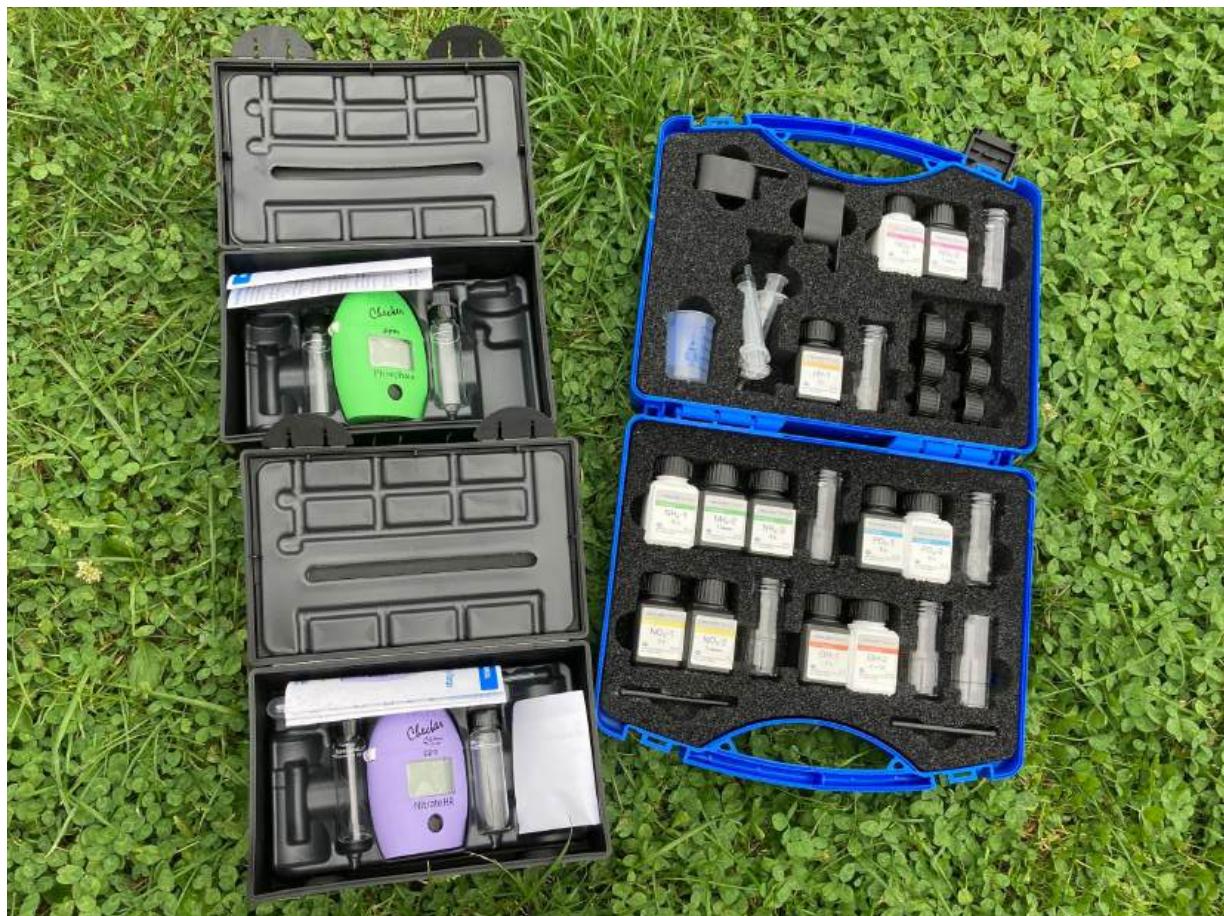
Figure 5. Testing kits used to analyze the water chemistry of the samples (M. Loit)

Subsequently, phosphate and nitrate ion concentrations in the water samples were analyzed with a Handheld Colorimeter Phosphate LR and a Handheld Colorimeter Marine Nitrate HR sensor, respectively (Figure 5). Total hardness was measured using Visocolor School drop titration test kits, series 933100.

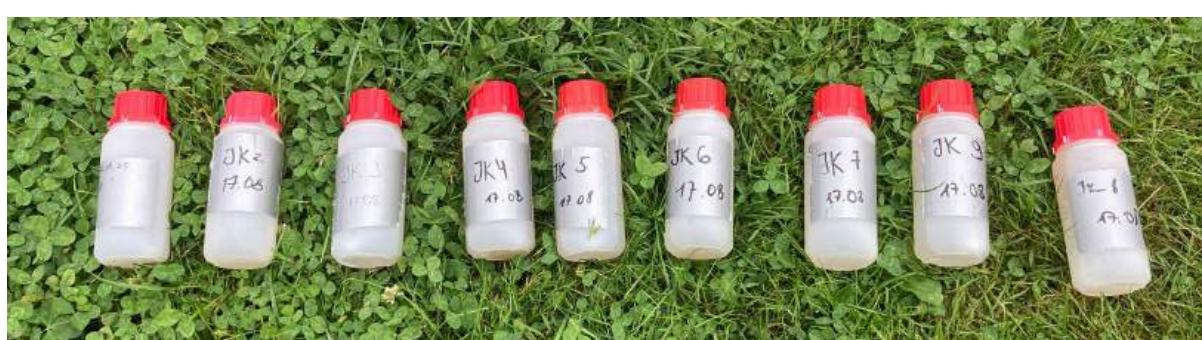
Figure 6. Sample bottles with water taken from each monitoring site (M. Loit)

All water samples were collected using a telescopic rod with sampling cups, with one cup assigned to each monitoring site. To avoid contamination from residual water, each container was rinsed three times prior to sampling. The sampling cups were labeled with the code *JK* (referring to the Jõulumäe trench) and the respective monitoring site number (Figure 6).

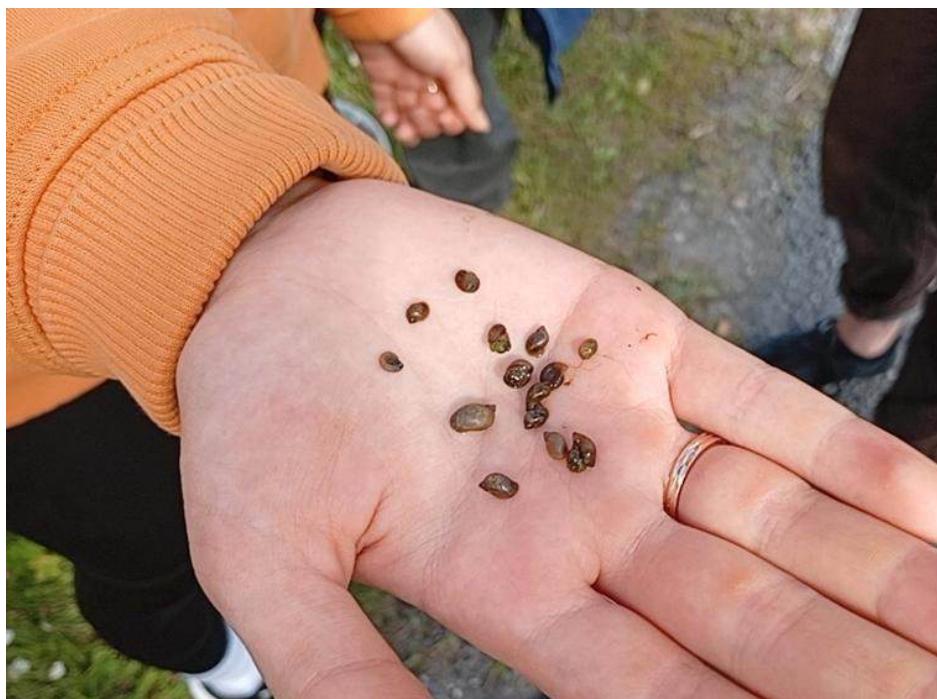
Our second research question concerned the composition of the benthic community along the sampling points of the trench. We hypothesized that the composition of benthic organisms would vary along the trench, and this was indeed confirmed. Near the sports facility, in the first sampling points, we observed a greater abundance of medicinal leeches (*Hirudo medicinalis*) and backswimmers (*Notonectidae*). In the last three sampling points, these taxa were entirely absent; instead, we found numerous mud snails (*Lymnaea stagnalis*) and wandering snails (*Radix balthica*).

Figure 15. An abundance of mud snails found from site JK7 (A. Vaarik)

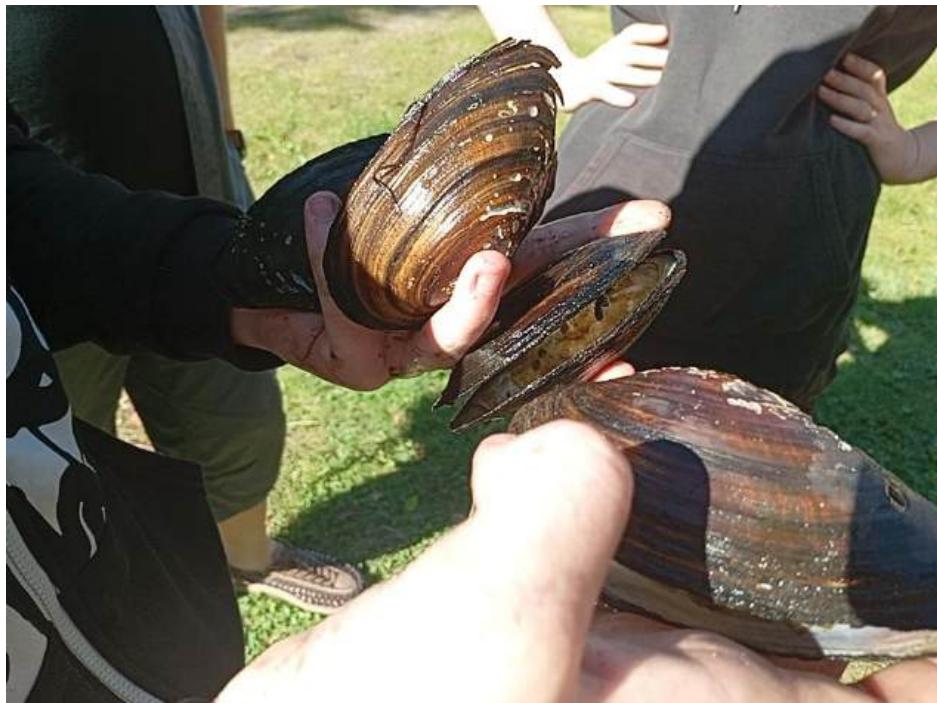
In the final point, located in an artificial pond, the biota was already markedly different: near the shore we observed many small fish and common pond mussels (*Anodonta anatina*).

Figure 16. *Anodonta anatina* found from site JK9 (J. Metsaalt)

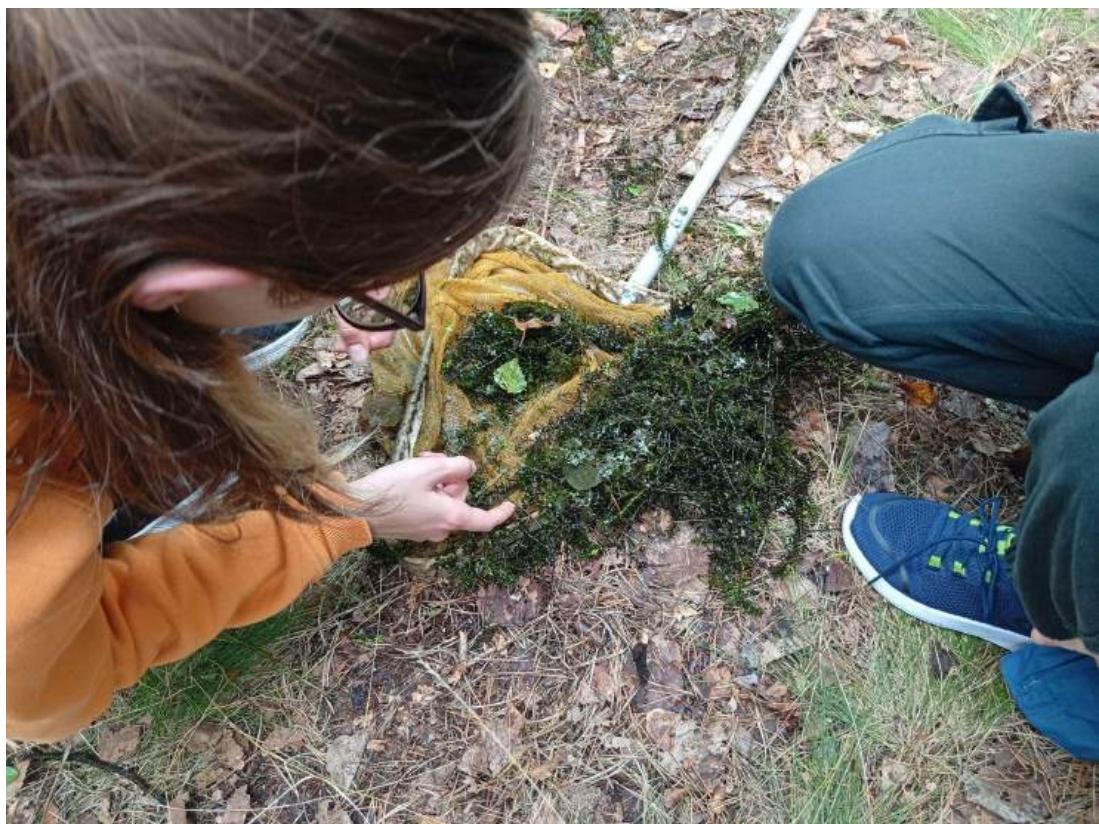
Starting from the sixth point, aquatic vegetation also changed: the dominant common duckweed (*Lemna minor*) was replaced by Canadian waterweed (*Elodea canadensis*).

Figure 17. A kick-net filled with *Elodea canadensis* from site JK6 (A. Vaarik)

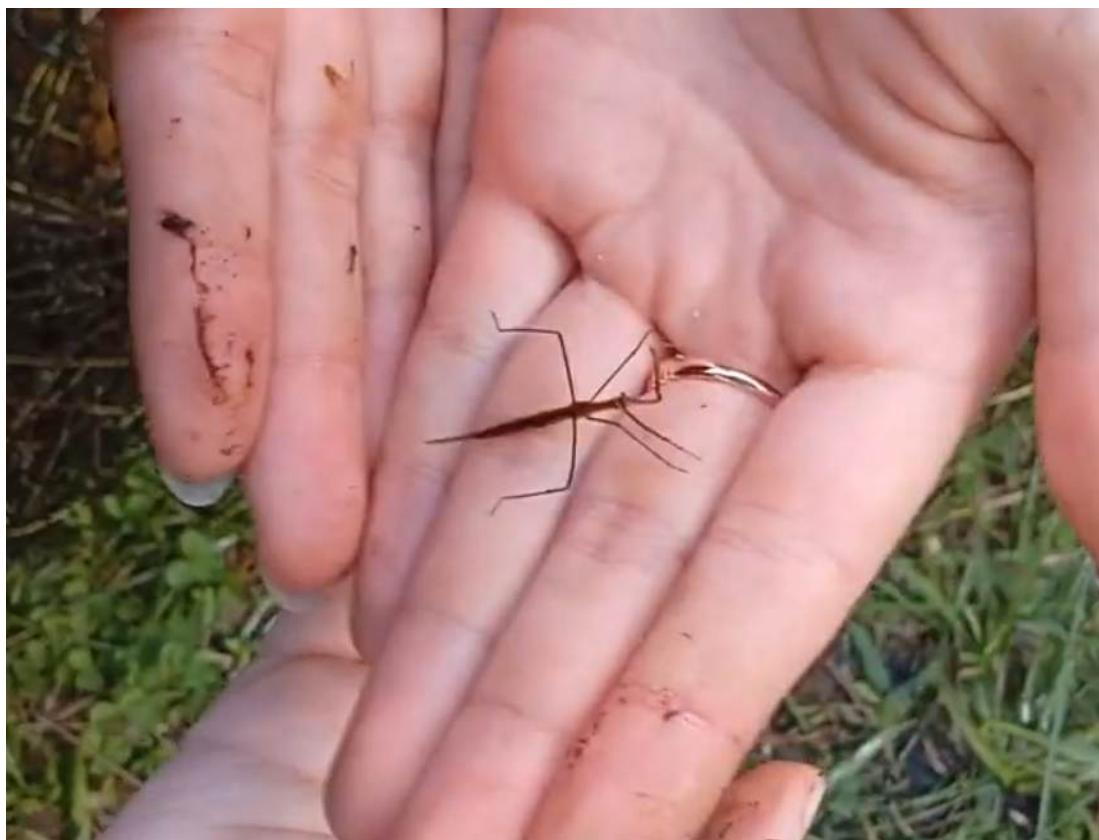
Water scorpions (*Nepa cinerea*) were recorded in points JK2 and JK9.

Figure 18. Water scorpion (*Nepa cinerea*) at JK2 (J. Metsaalt)
