How healthy is our Local Deansgrange River?

Citizen Science @ Rockford Manor

Abstract

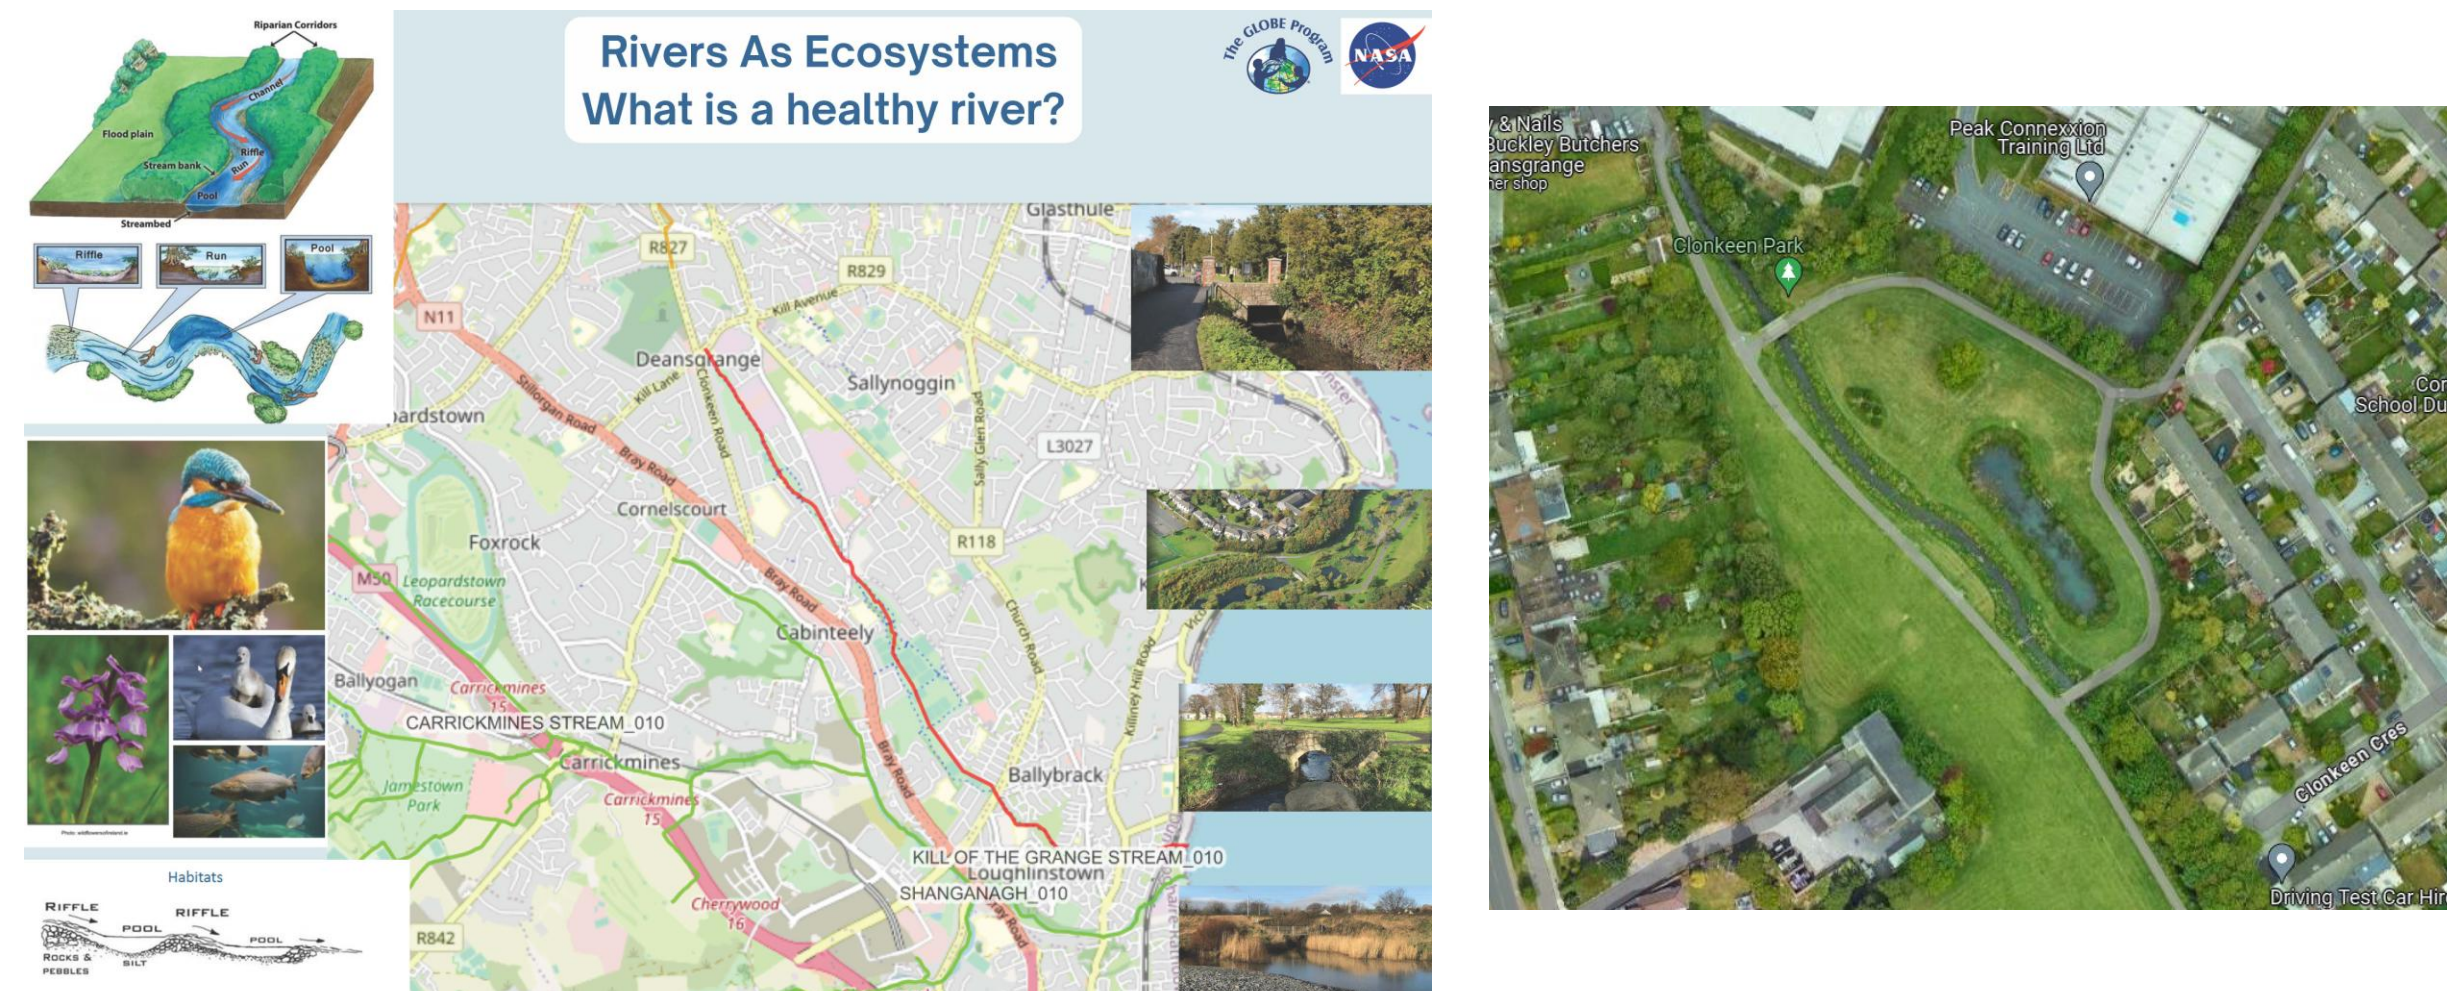
Our school Rockford Manor is located in Blackrock, Co. Dublin. We studied our local river, the Deansgrange stream that is located a distance of 2km from the school. The Deansgrange catchment, the land that drains to the Deansgrange stream, is a relatively long and narrow area, stretching from Deansgrange in the northwest to Loughlinstown in the southeast. We based our studies on the section of this river that is located in Clonkeen Park behind the SuperValu Deansgrange supermarket. This urban park runs between Clonkeen Road and Pottery Road where there is a mix of residential properties, commercial and industrial facilities. In recent years works associated with the Deansgrange Flood Relief Scheme have been carried out and we noticed a deepening of the river bank and the installation of a wetland area to mitigate the risk of future flooding to nearby properties.

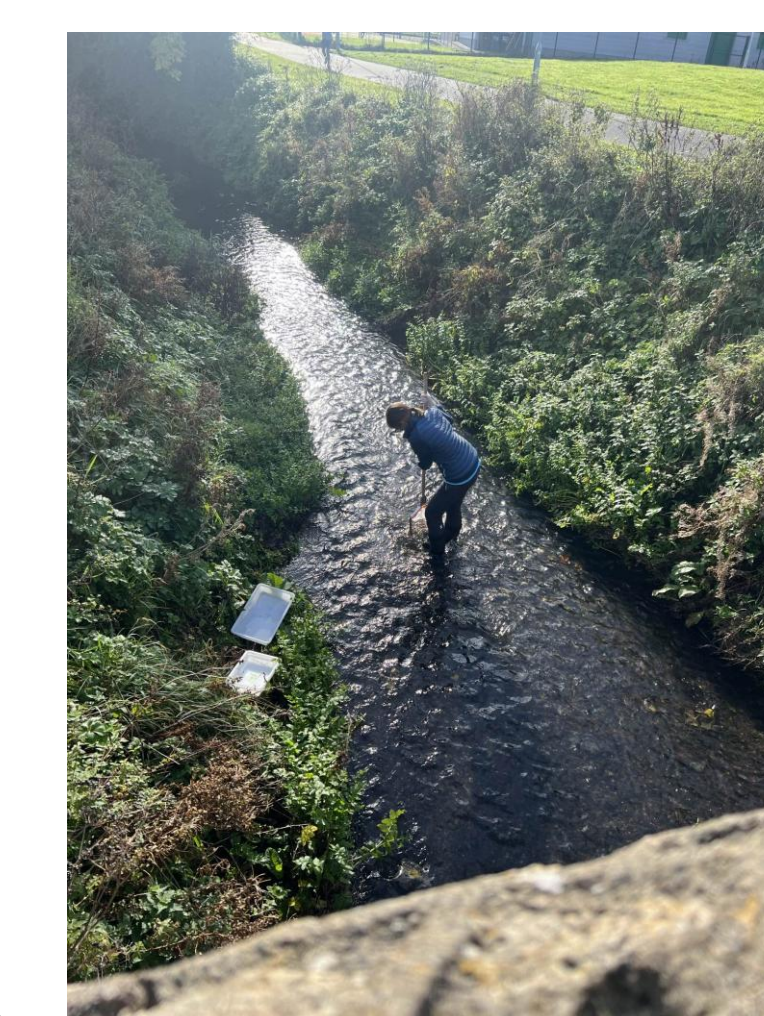
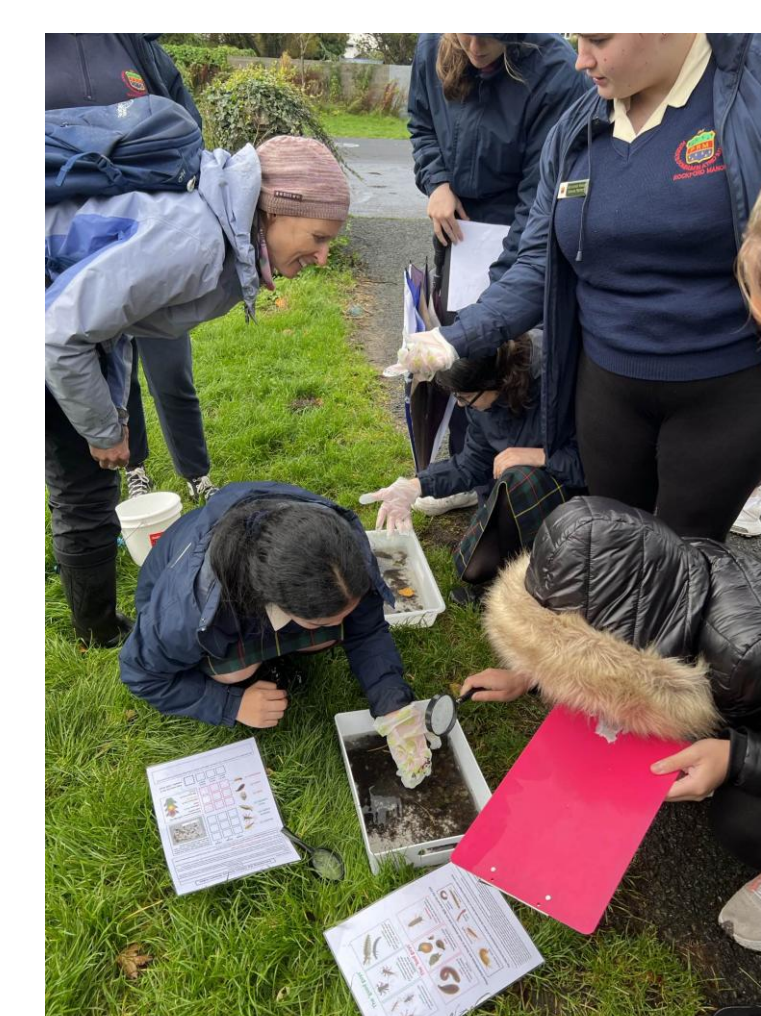
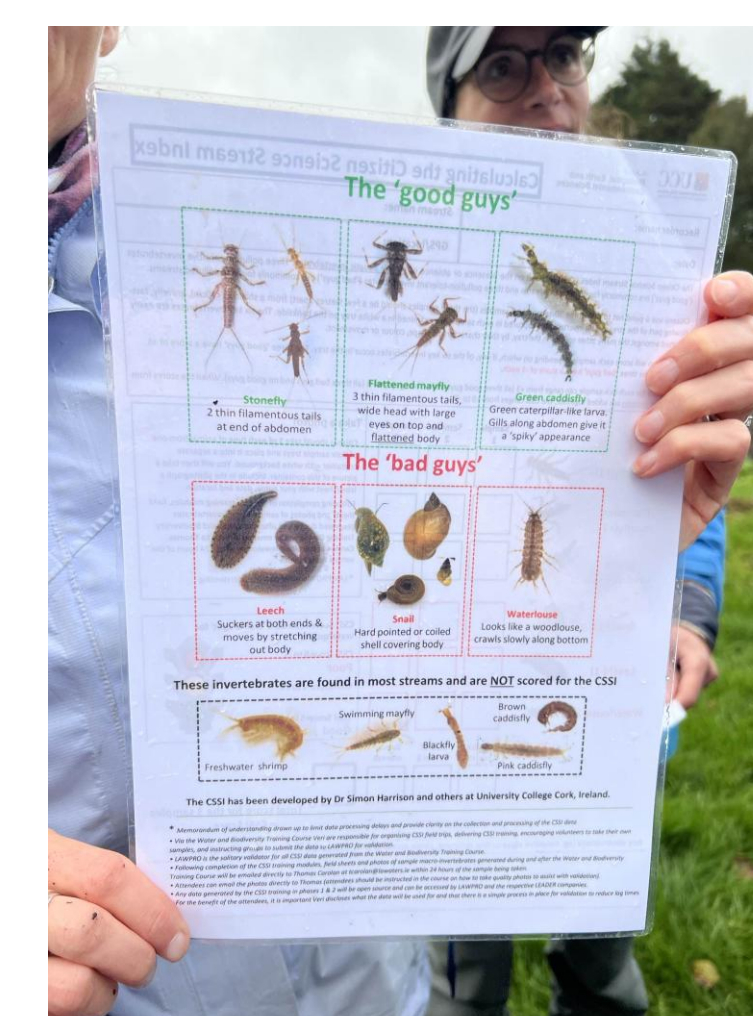
- A **bucket and rope** were used to collect water samples from the river. Sampling **protocols** were adhered to such as rinsing the bucket 2 to 3 times and trying not to disturb the bottom of the stream.
- Water **temperature** and **pH** was measured and recorded
- **Nitrate** and **phosphate** test kits were used along with comparator colour charts to determine nutrient concentrations

- Kick sample testing was carried out on the river bed to investigate the species of **freshwater invertebrates** present. Identification keys were used to name any creatures found.

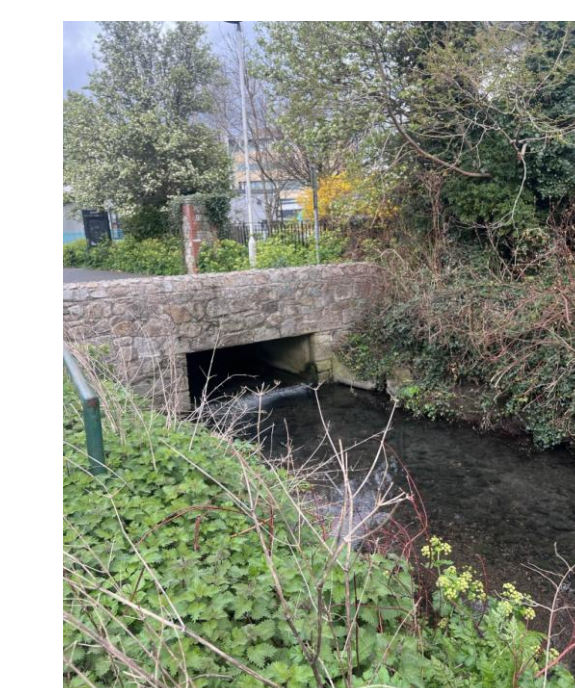
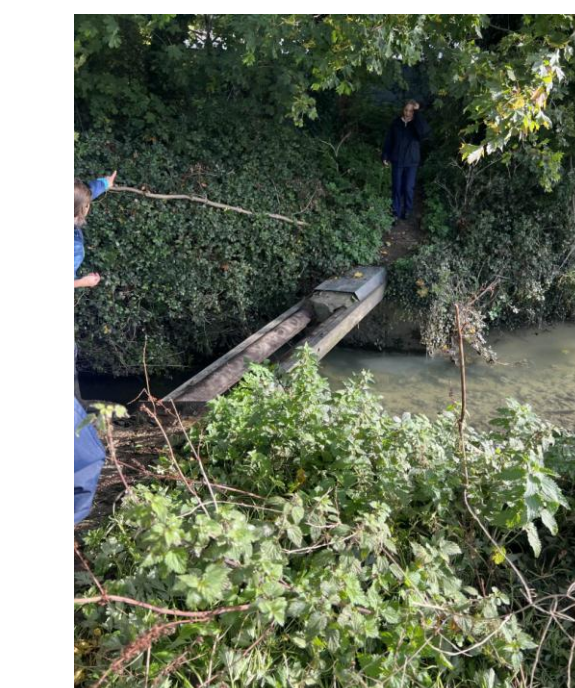
On all of our visits we noticed **rubbish** in and around the river; plastic and metal items along with coffee cups and a shopping trolley. On one occasion we noticed some effluent entering the river from a pipe. The water turned cloudy at this location.

- Our results indicate that our local river in Deansgrange **may not be as healthy as we would like it to be**.
- **Elevated nitrate levels** may be due to fertilizers entering the water upstream.
- The presence of **rubbish** in the water and the mystery **effluent** entering the water could also indicate poor river health.
- Another concerning finding of our studies is the **absence of pollution-sensitive invertebrates** such as green caddisfly, stonefly and flattened mayfly which are **indicators of good water quality** and **the presence of invertebrates such as leeches and snails which indicate poor water quality**.
