# Ten-year Study of Piledriver Slough

## Teslin Brannan & Rusty Baker

*Ben Eielson High School & BEST Homeschool, Fairbanks, Alaska*

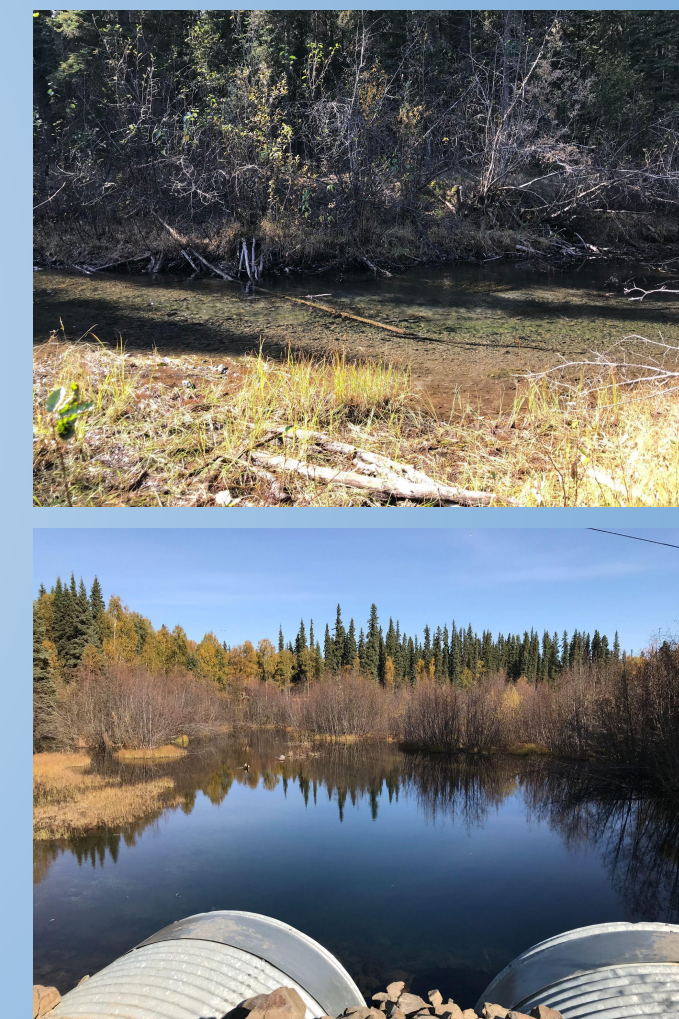
- Dam (new land development)
- Riffles (remote, old beaver site) \*see pic to right
- Xanthus (wooden residential bridge)
- 4 Wheeler Track (ATV trail through slough, recent beaver site)
- Ingrid Dr. (metal residential bridge)
- K-Bs (commercial flower farm, recent beaver site)
- Culvert A (large passage south side of gravel road)
- Culvert B (large passage north side of gravel road) \*see pic to right

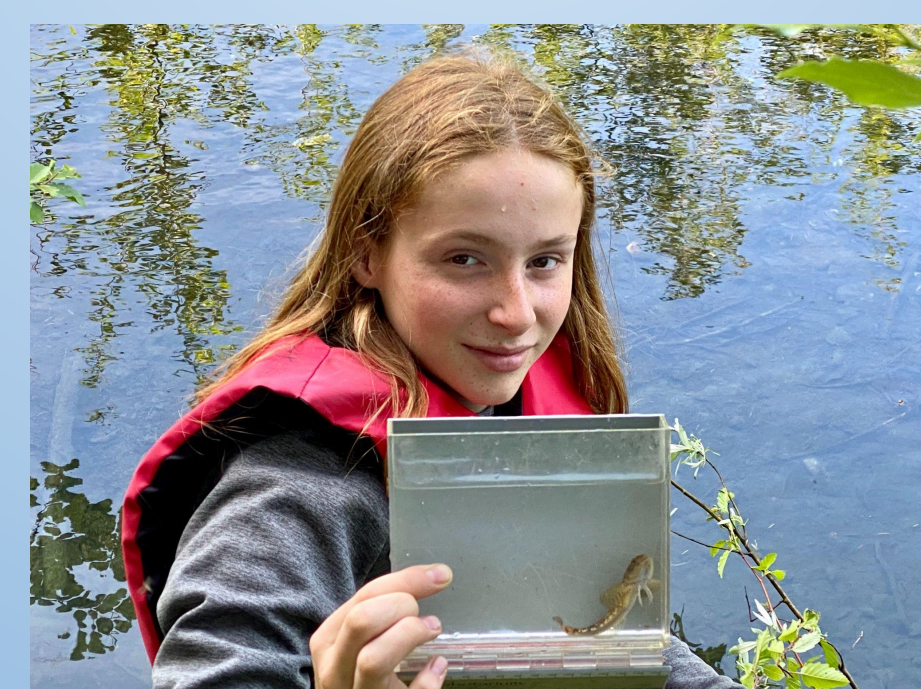
Slimy Sculpin Measuring in a Photarium

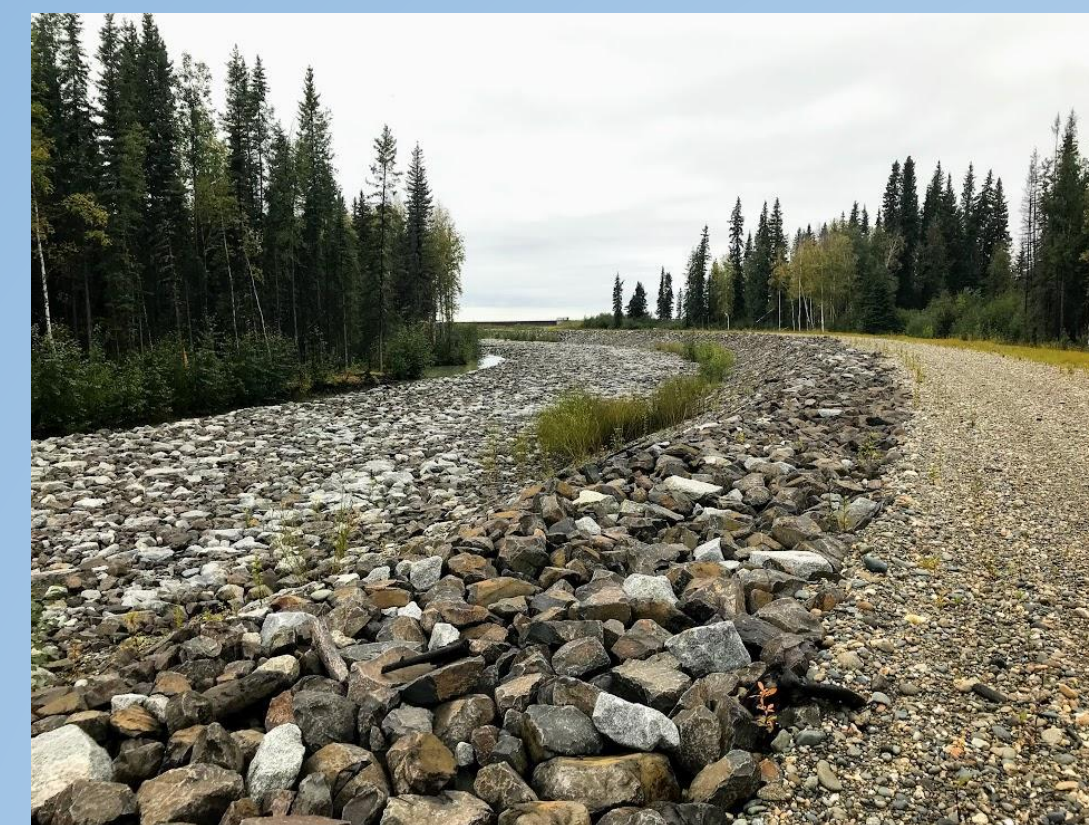
Tanana Crossing Levee Upriver from Bridge

When the levee cut off the head of Piledriver Slough it was no longer fed or flushed by the Tanana River, relying solely on ground water. We were concerned that this might affect the slough's habitat for sport fishing and as a salmon spawning area. With the lack of "flushes" from the Tanana River, beaver dams increased (until removed under permit) and vegetation in the riparian zone changed. Recent low counts of salmon in the Salcha River have resulted in local fishing closures to reach escapement quotas for the Yukon Territory. Many families in our community rely on these fish for subsistence.

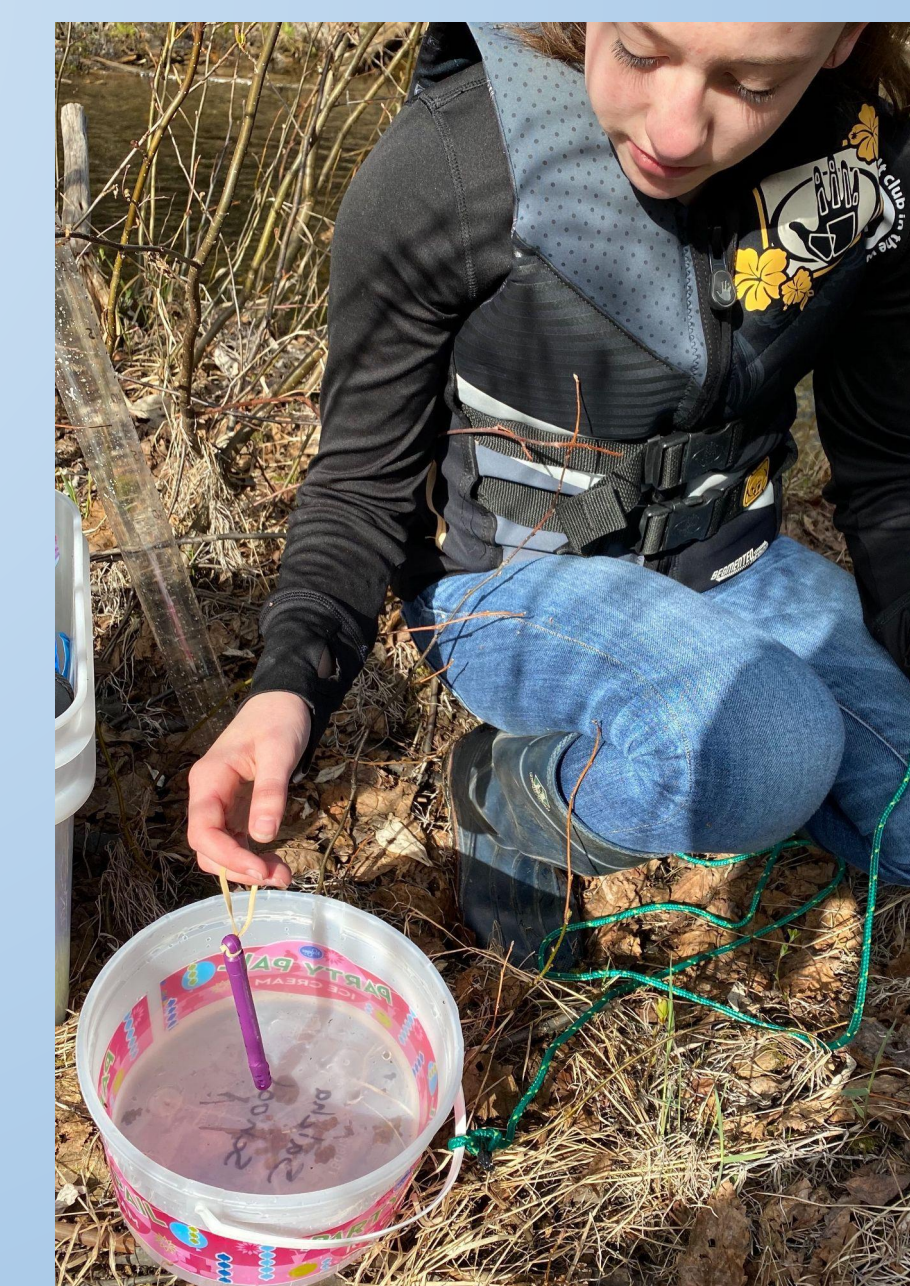
Water Temperature Measurement with Alcohol Thermometer

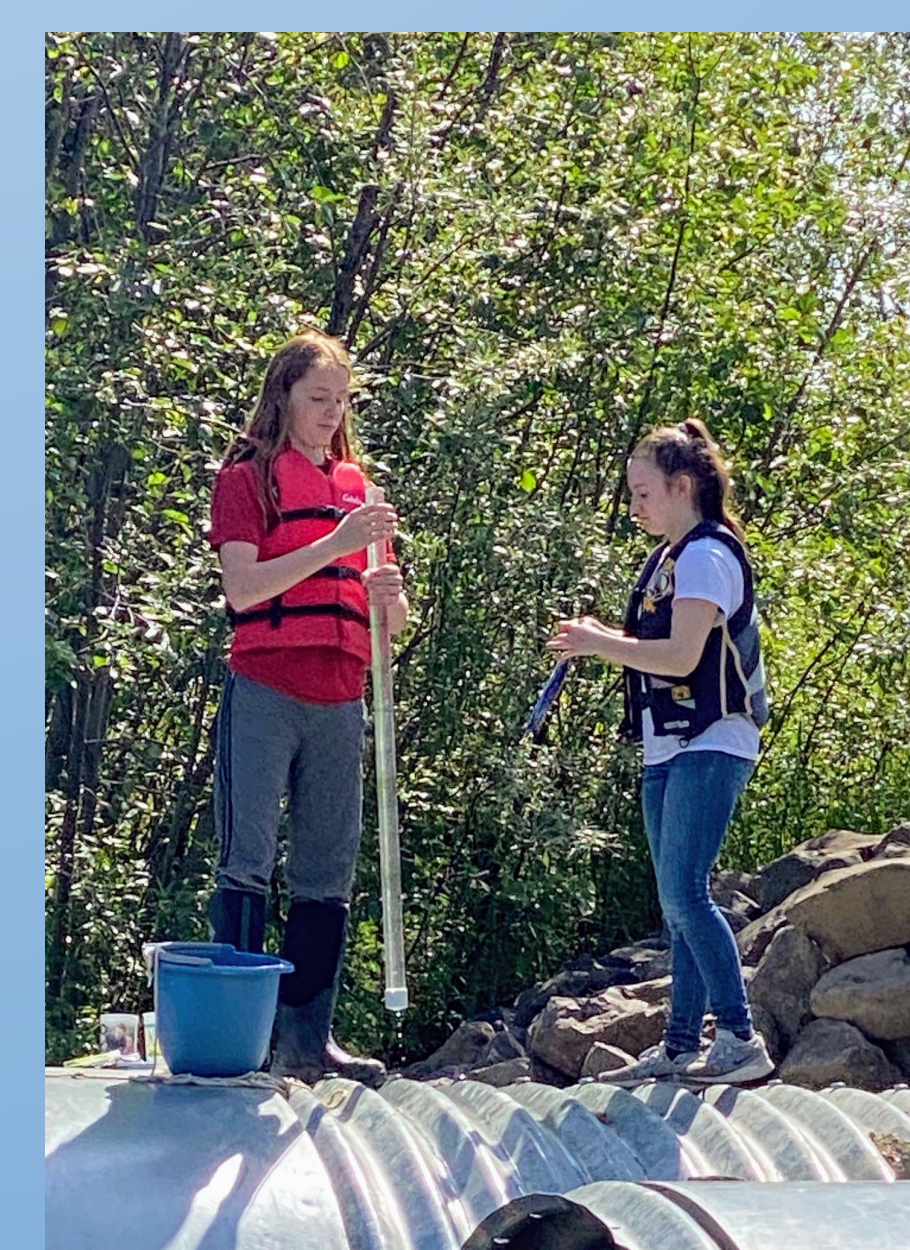
Measuring Turbidity at Culvert Sites

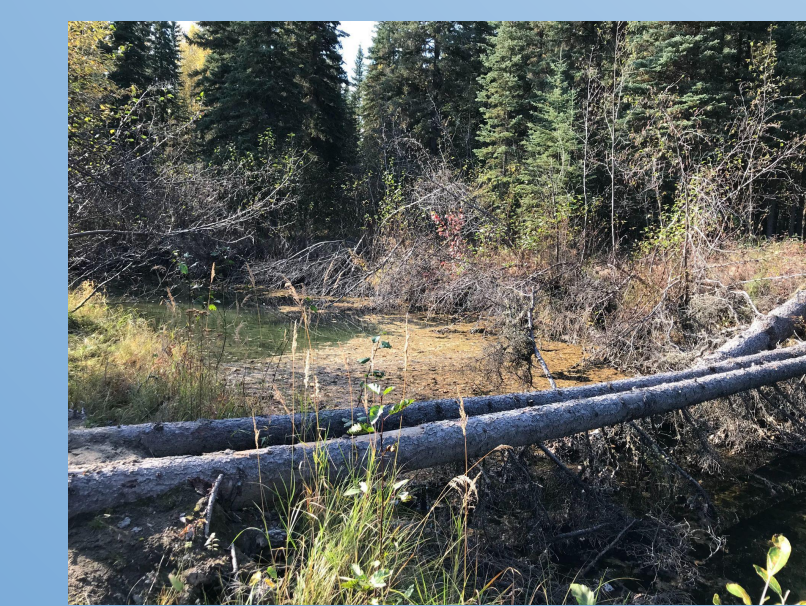
Algae Bloom Upstream of Dam Site

Along with blocking off the head of Piledriver Slough, forcing it to be groundwater fed only, we have noticed more landowner development, decreased healthy riparian zones, increased algae blooms, decreased varieties of species of fish, and decreased deeper pools due to removal of beavers and their dams, all of which may be leading to increased water temperatures.

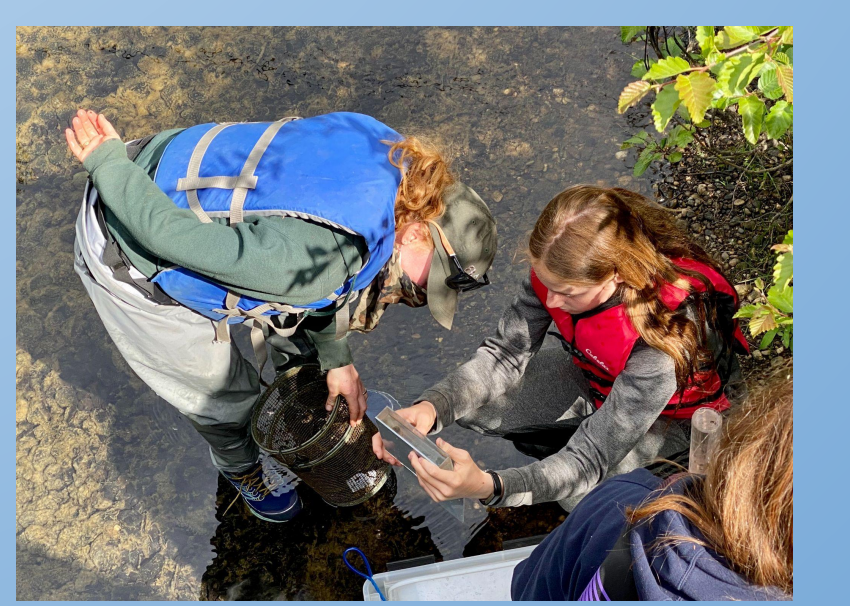
Removing and Measuring a Fish from the Minnow Trap

- The Piledriver Slough study took place in the spring, summer, and fall of each year starting in summer 2012 through fall 2021.
- Two minnow traps were set up the day prior at each of the eight sites, baited with salmon roe to catch juvenile fish for identification.
- The following day Salcha Elementary students, staff, and alumni were bused to their field site (divided by grade level groups) where the minnow traps were checked and the fish identified with the assistance of school staff/alumni and TVWA scientists.
- Water samples were collected, measured and recorded at each of the eight sites for Temperature, Dissolved Oxygen, Turbidity, and pH using GLOBE hydrology protocols and Hannameter probes on the same day.
