How Healthy is our Local River?

TY Students, Rockford Manor Secondary School, Dublin, Ireland

5th March 2025

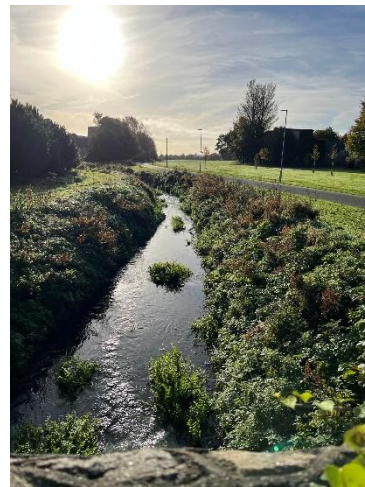
Student worksheet, gloves, bucket, rope, thermometer, pH strips & chart, nitrate & phosphate test tubes, sample net, freshwater invertebrate identification key and trays.

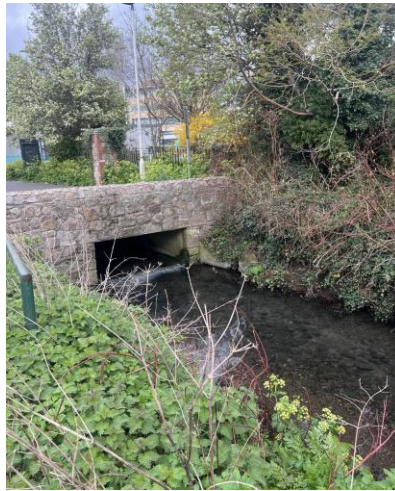
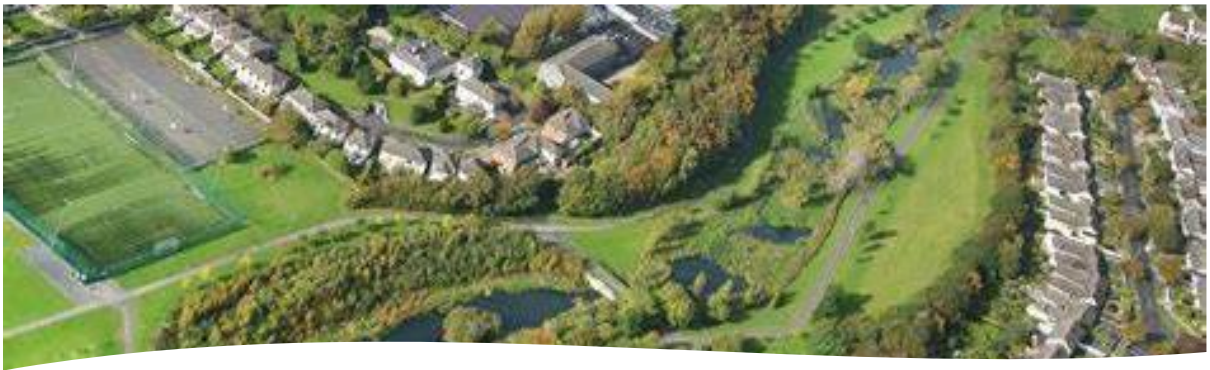
4.2. Visual Inspection

Students took time to walk quietly along the river to observe and record the following details in their **worksheets**.

- The **type** of waterbody, **width and depth**
- Visual **appearance** of the water and the **local habitat**
- **Flora and fauna** of the immediate area

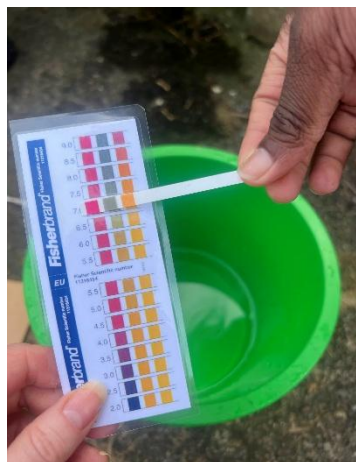
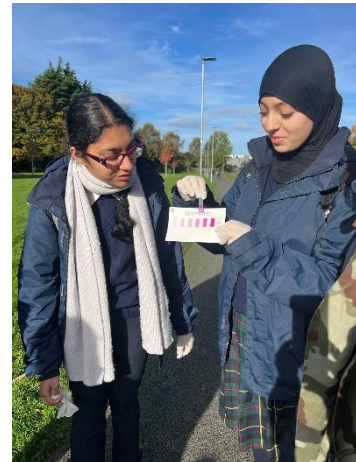
4.3. River Water Quality: Snapshot of Chemical Properties

- A **bucket and rope** were used to collect water samples from the river. Sampling **protocols** were adhered to such as rinsing the bucket 3 times with river water and trying not to disturb the bottom of the stream.
- Water **temperature** and **pH** was measured and recorded 3 times and the average recorded.
- **Nitrate** and **phosphate** test kits were used along with comparator colour charts to determine nutrient concentrations

The average results of the chemical properties of the water are summarised in the table below. Our tests indicate high levels of nitrates and acceptable levels of phosphates in the water. A neutral pH was measured and the water temperature ranged from 10 to 14°C.

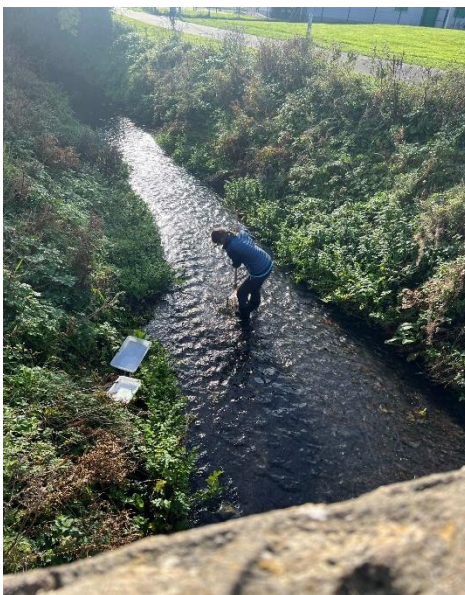
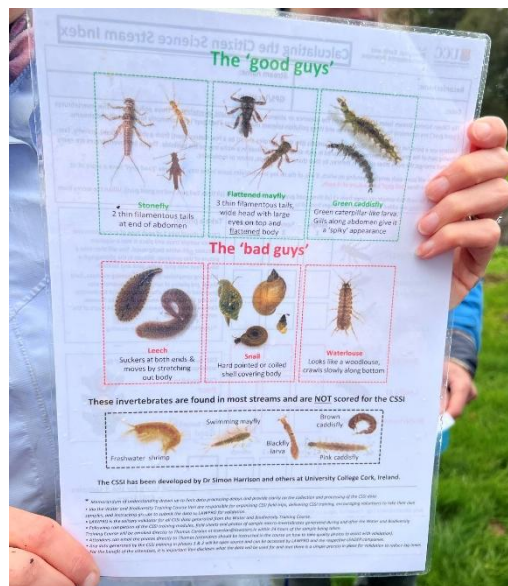
4.4. Kick Sample Testing

- Kick sample testing was carried out on the river bed to investigate the species of **freshwater invertebrates** present.
- Identification keys were used to name any creatures found.

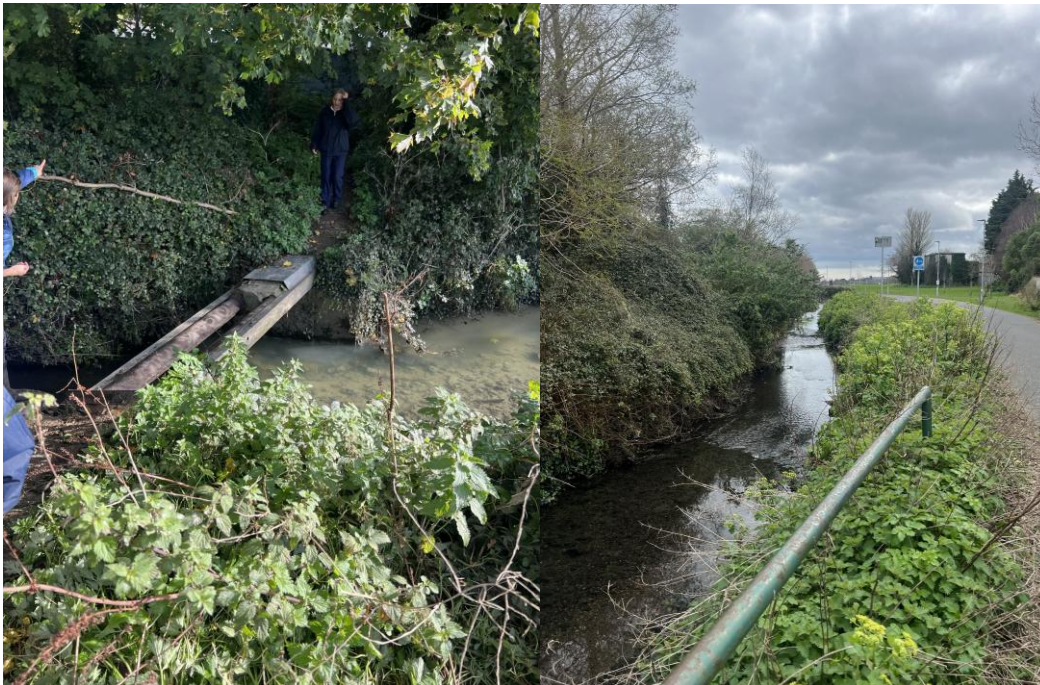
On all of our visits we noticed **rubbish** in and around the river; plastic and metal items along with coffee cups and a shopping trolley. On one occasion we noticed some effluent entering the river from a pipe. The water turned cloudy at this location.

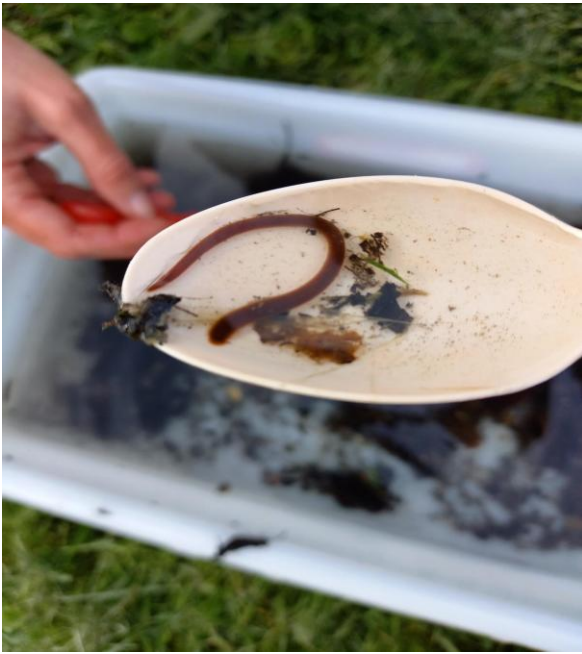
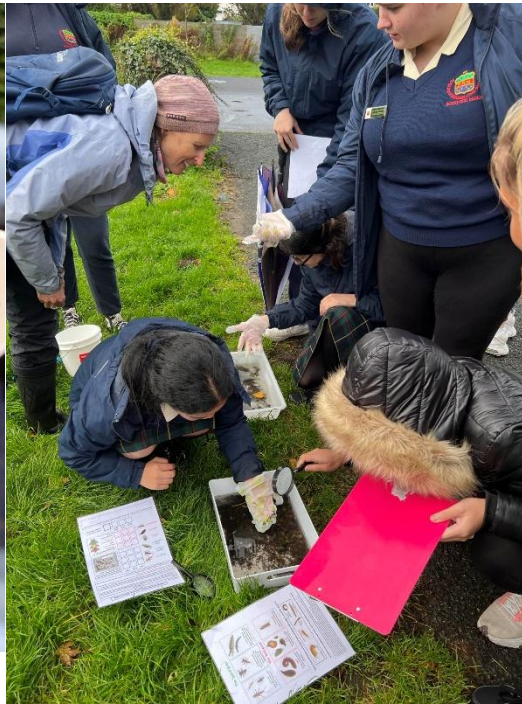
5.3. Kick Sample Testing

Samples from kick sample testing indicated a high amount of freshwater shrimp in the river, along with some water snails, leeches and water lice. These aquatic invertebrates are pollutant tolerant species.
