El Ceibo Stream under the microscope:
Impact of human activity on an aquatic ecosystem

Victoria - Entre Ríos – Argentina

2026

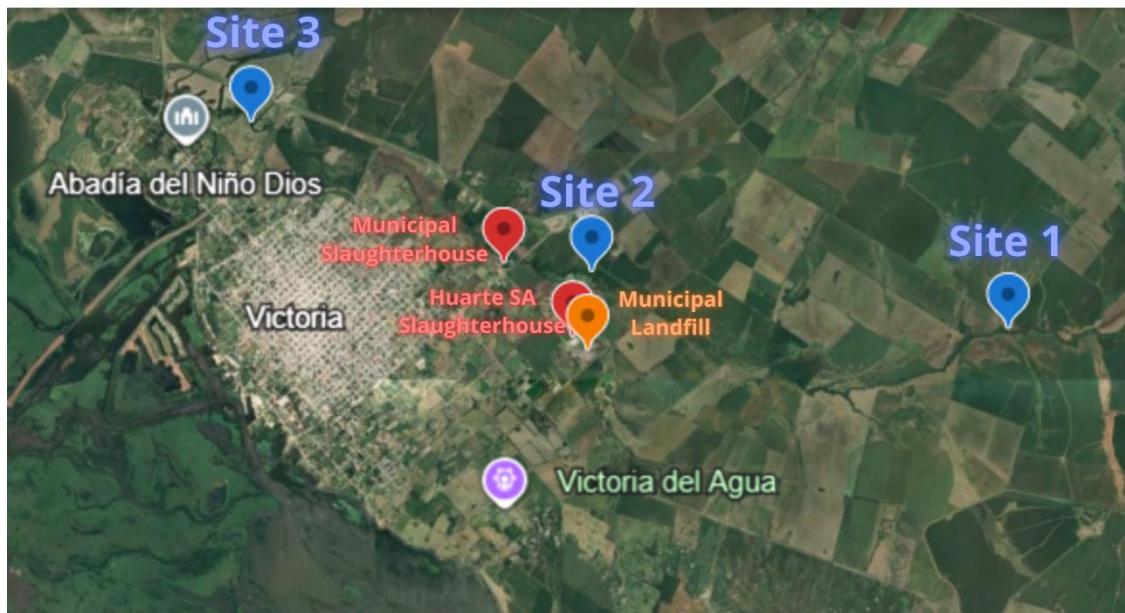
Figure 2. Location of the study sites (blue icons) in relation to the city of Victoria, the slaughterhouses (red icons), and the municipal landfill (orange icon).

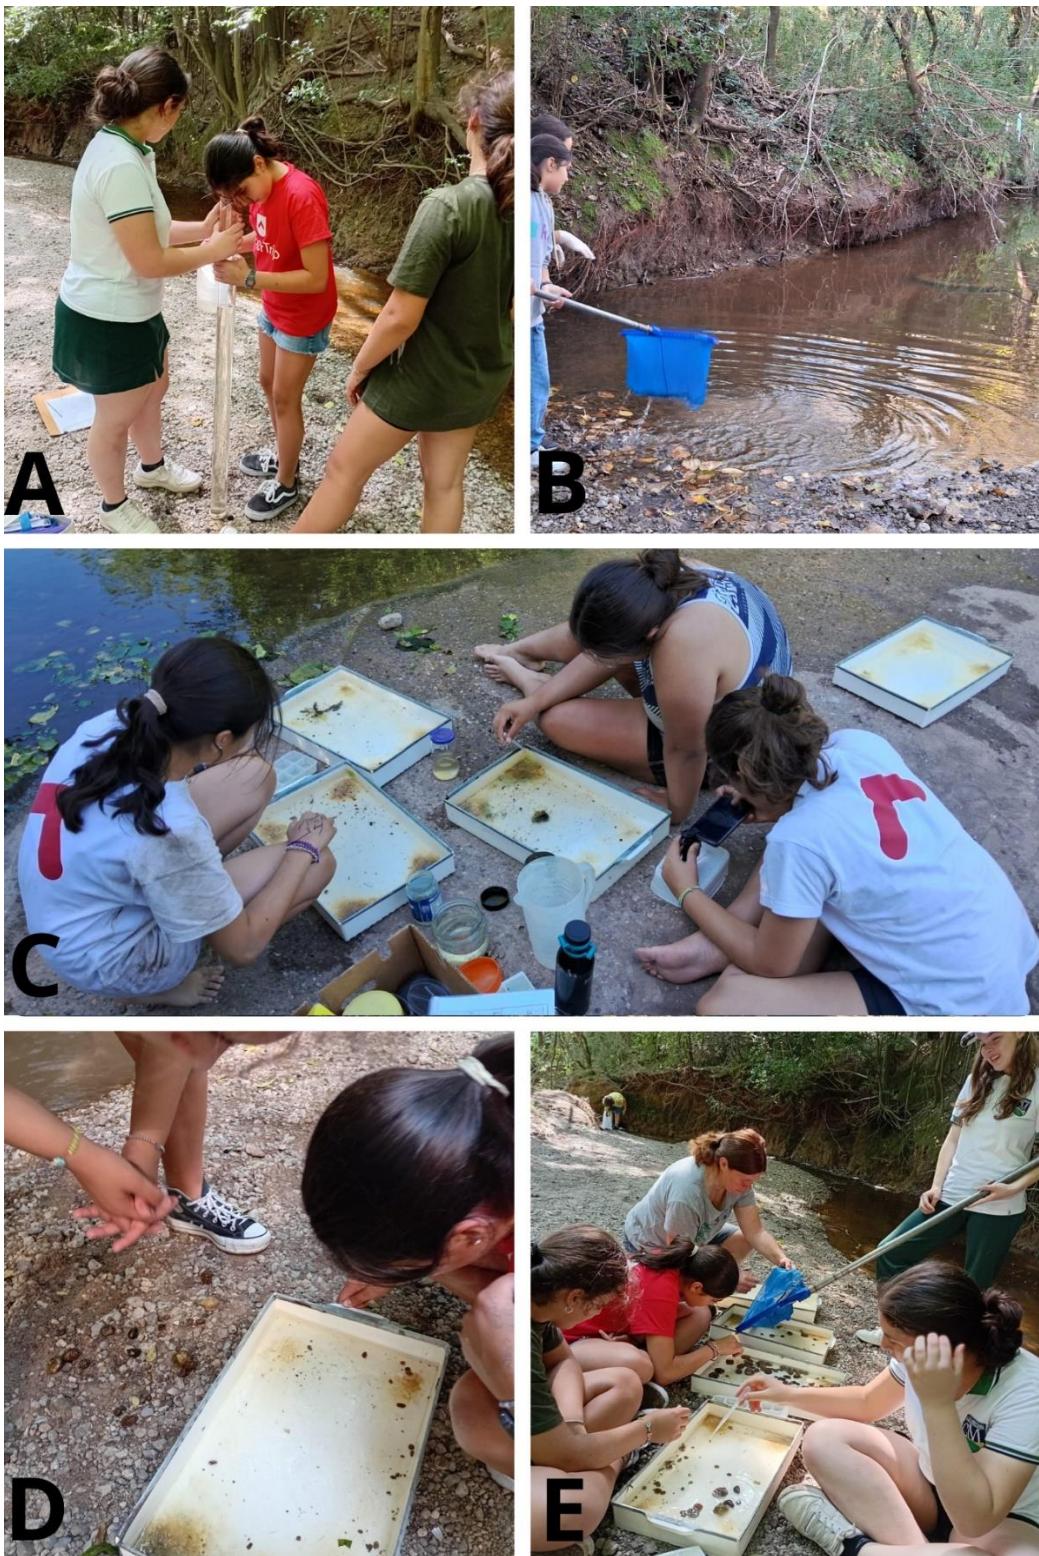
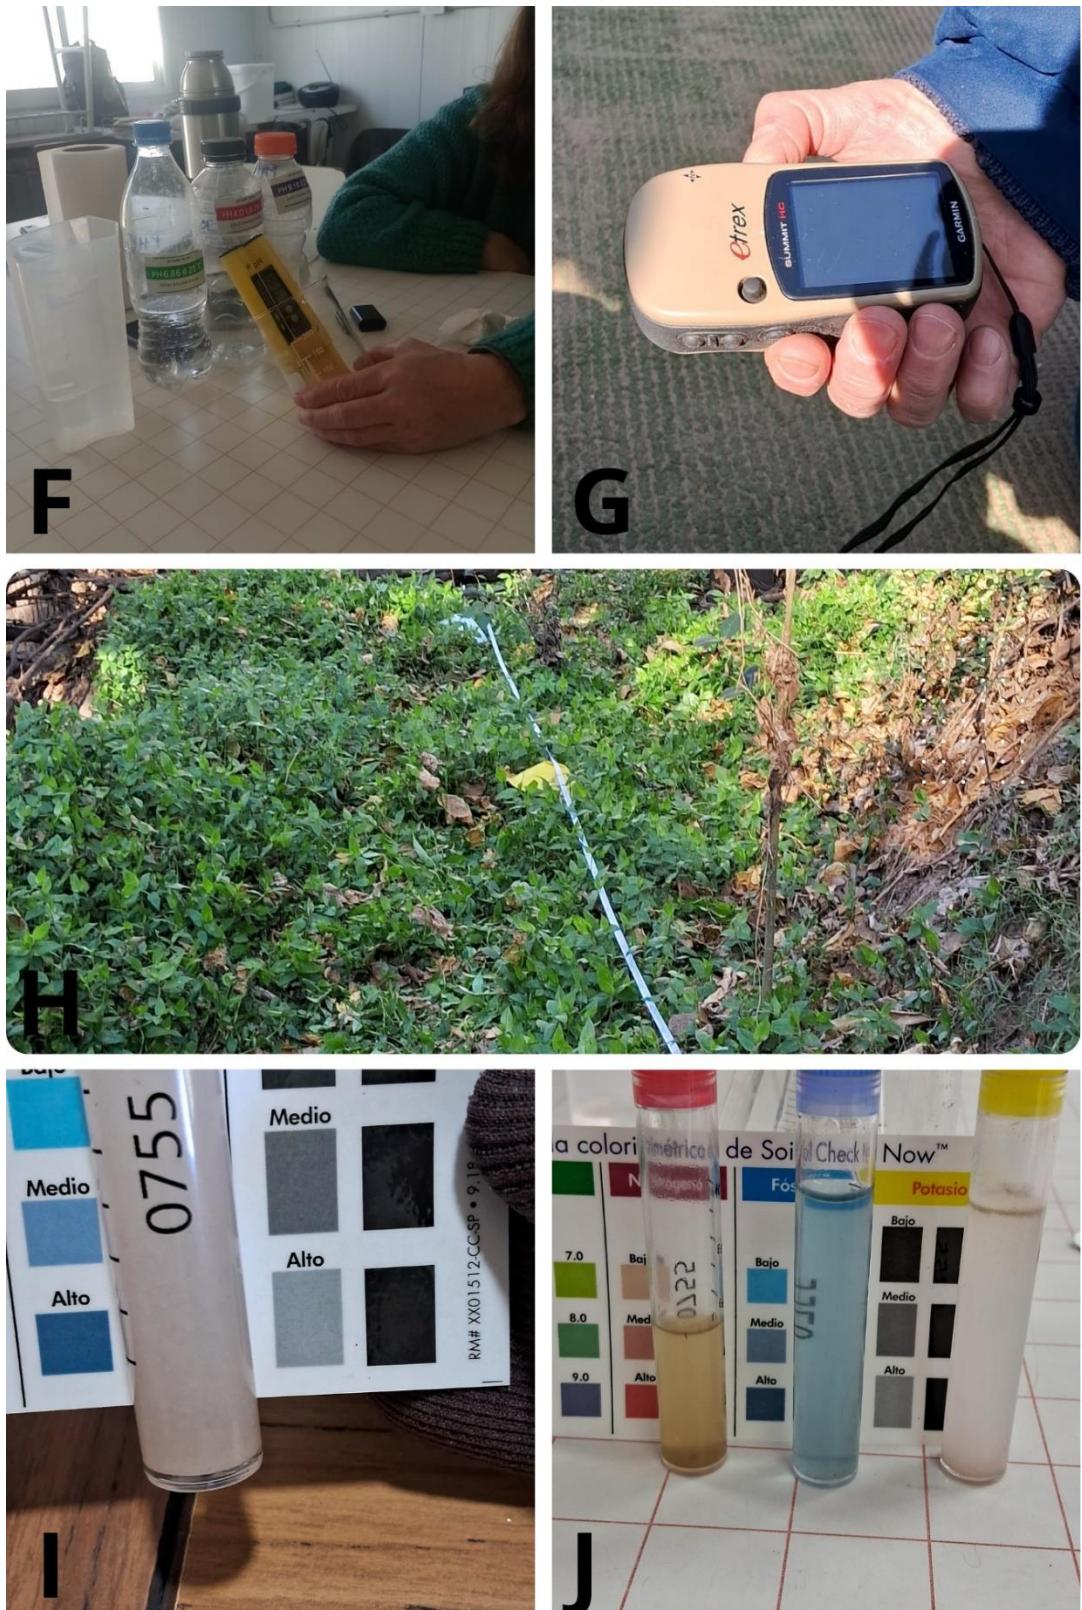
ANNEX 2. Members of the research group collecting data.

Figure 4. A – Carrying out the water transparency protocol. B, C, D and E – Macroinvertebrate sampling and subsequent identification and classification. F – pH meter calibration protocol. G – GPS usage protocol. H – Mapping of Site 1. I and J – Soil fertility protocol.

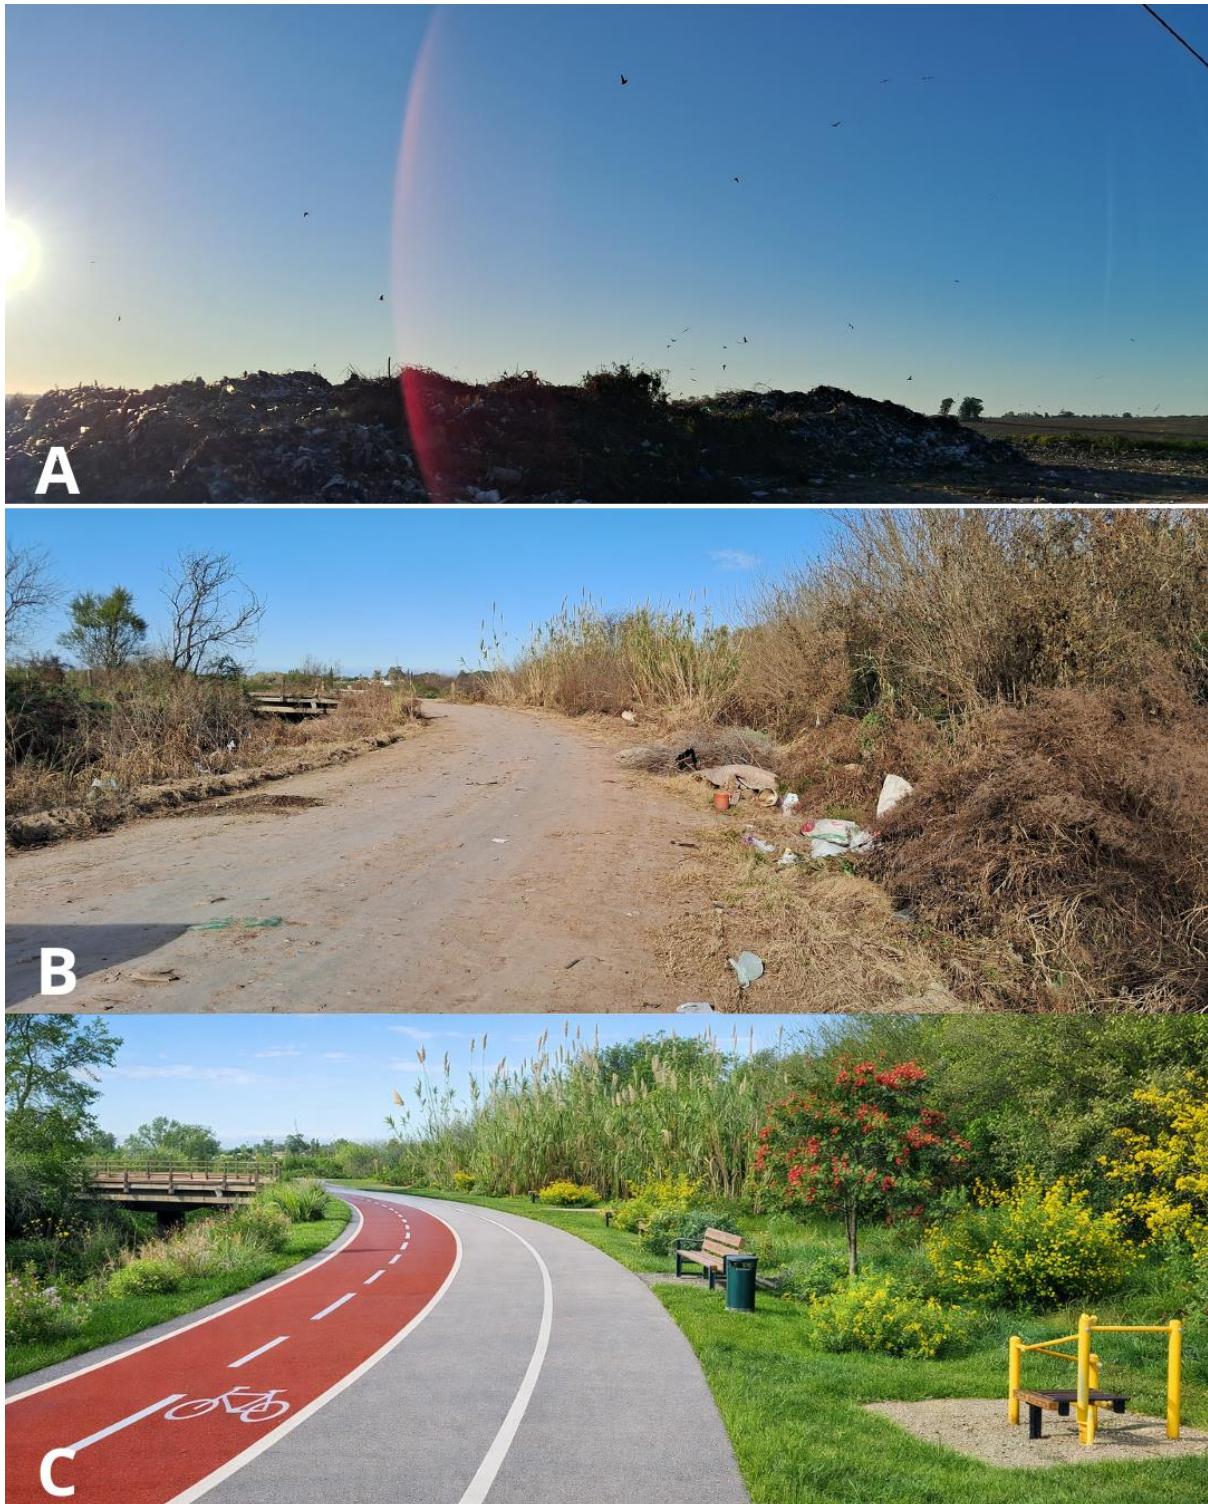
ANNEX 4. Anthropogenic impact and opportunities for environmental restoration in the surroundings of Arroyo El Ceibo.

Figure 6. A – Open-air landfill of the city of Victoria, Entre Ríos, Argentina. B – Degraded landscape along Camino del Puente Verde. Visual evidence of environmental deterioration. C – Potential landscape of Camino del Puente Verde: Arroyo El Ceibo as an environmental corridor. Source: Own elaboration based on field photographic records, with assistance from generative artificial intelligence.

It is evident that once the watercourse enters the urban area, in addition to the previously mentioned changes, the presence of solid waste of anthropogenic origin can be observed, such as polyvinyl chloride¹¹ (PVC) plastic bottles and a large quantity of polyethylene bags that are carried by the current, especially during periods when the stream's flow increases due to precipitation. When the stream passes through private properties, it is not possible to assess the level of care provided; however, in public areas, the highest accumulation of waste is observed in the surrounding environment. At Site 1, corresponding to the rural area, the solid waste mentioned above was not observed, unlike Site 2, where only a small amount was found, possibly because it is a private recreational complex where maintenance staff regularly perform cleaning tasks. Site 3 and other freely accessible sectors of El Ceibo Stream, such as the area known as "Puente Verde," show marked visual pollution associated with inadequate waste disposal practices by some citizens. This situation not only affects the landscape but also negatively impacts environmental quality and the organisms inhabiting the watercourse. The problem is exacerbated by the lack of sustained environmental management actions, such as regular cleaning, space-use control, and the development of environmental education and prevention strategies by the municipality, which hinders the conservation of these areas as natural and recreational spaces.
