Assessment of Water Quality at the Chatanika River, Alaska

¹ University of Alaska, Climate Scholars

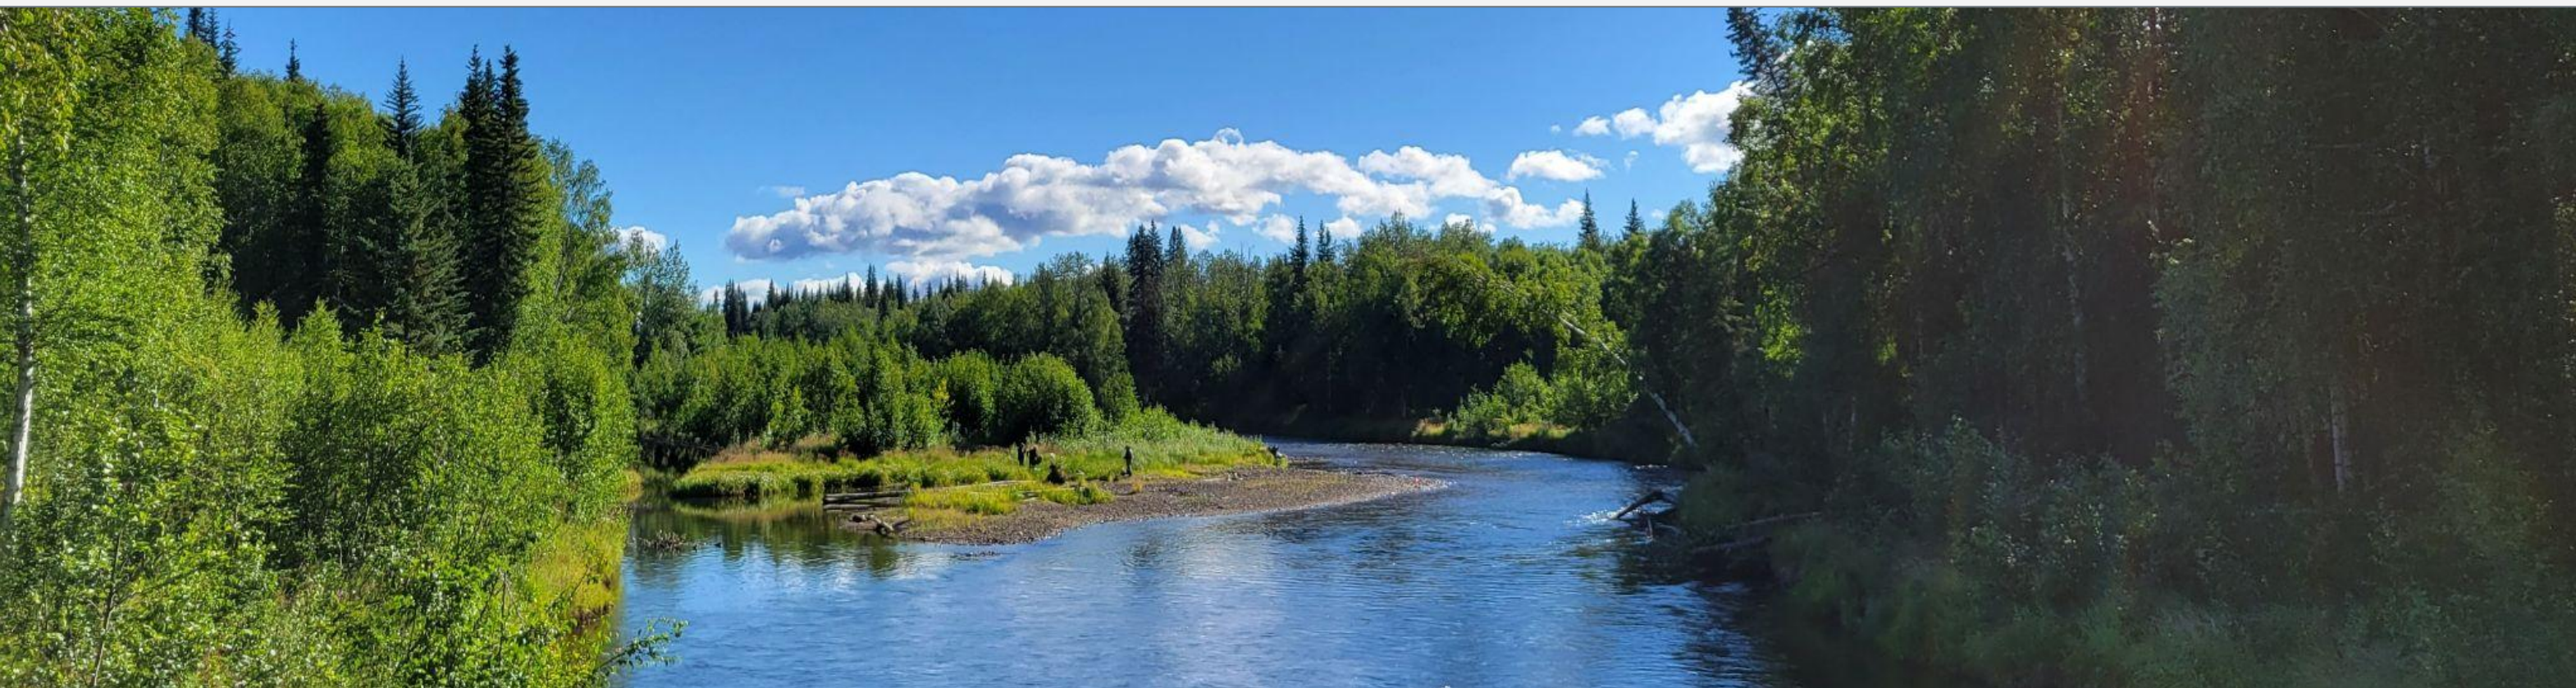
Fig. 1. Photo taken from the LTER bridge over the chatanika bridge, overlooking our transect and water sample sites.

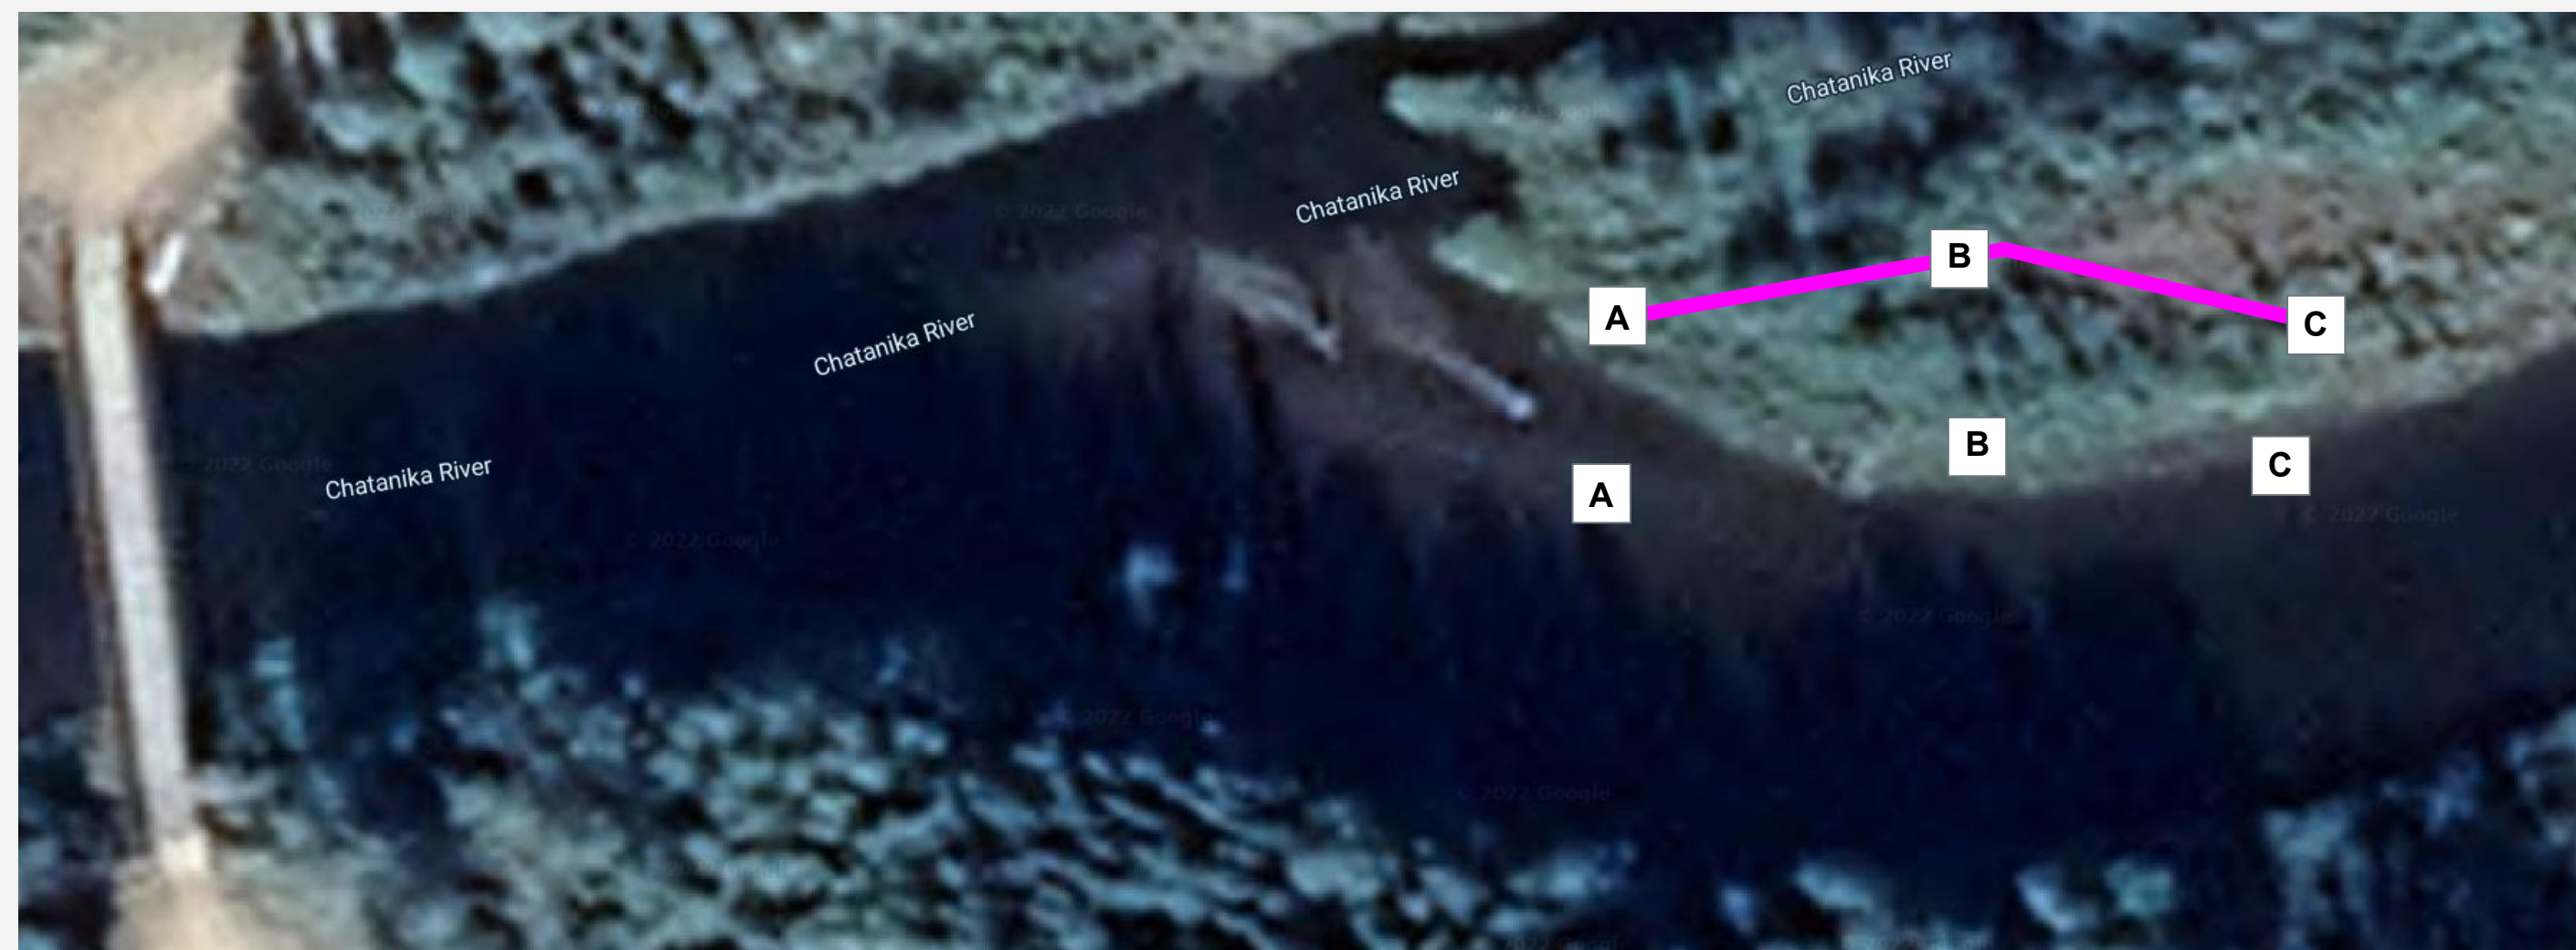
Fig. 2. Overhead view of our transect and overall site.

- Vegetation was surveyed along a 50 m transect using the point-intercept method near the Chatanika River (65.14100, -147.45525).
- From the transect pts A, B, and C at 0m 25 m and 50 m respectively, we approached the adjacent water(river) at approximately 90 degrees to place the flag from which we sampled our water parameters (DO, temp, turbidity, etc.).
- To assess water quality, the following were measured using GLOBE (Global Learning and Observations to Benefit the Environment) protocols: turbidity, dissolved oxygen, water temperature, and water pH.
- Using STROUD's Stream Study: Sample Record and Assessment to count the macroinvertebrates and then calculate the total index value as an indicator of water quality.
- Used GLOBE mobile app to document land cover to describe dominant vegetation along point-intersect of transect.
