Discussion on the Surface Soil Behavior of Landslides in Keelung Area

Sampling the topsoil at the locations where landslides occurred in Keelung City, compared the topsoils of different slope directions in the school, to understand the characteristics of the soils that have occurred in the past landslides. The surface soil of the landslide site is mostly coarse-grained sandstone, mostly facing the northeast, and the strata under the surface are mostly sedimentary rocks. The time of landslides is mostly winter to spring, which is the rainy season in Keelung City. According to the spectrum of the sampled soil images, it is found that the surface soil in this area usually absorbs more long waves. Traditionally, precipitation is used to monitor where landslides may occur. If monitoring of surface soil can be added, the chances of preventing landslides can also be improved.

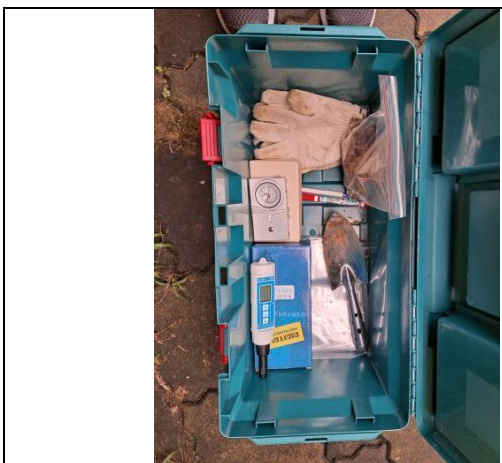
figure(2) Research tools

Gloves, shovel, inclinometer, thermometer, barometer, zipper bag, pen as shown in figure (2)

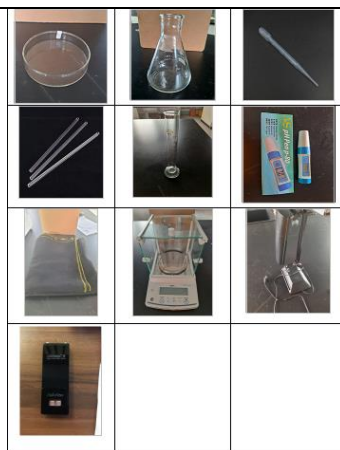
figure(3) Research tools

Petri dishes\*6, Erlenmeyer flasks\*6, droppers, glass rods, measuring cylinders, pH meters, black cloths, electronic scales, desk lamps, spectrometer , Cellphone as shown in figure (3)

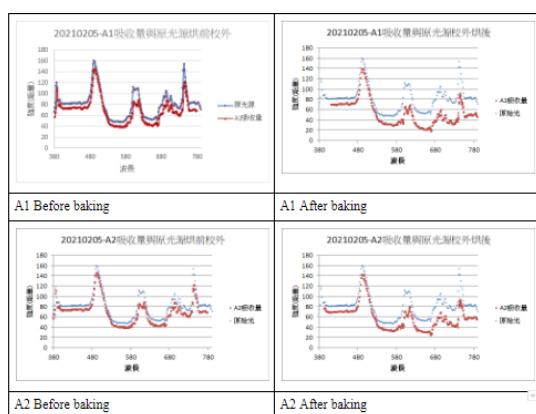
Fig(5)

From these pictures, it can be seen that the partial absorption of the long-wave spectrum after the baking soil is reduced, In the picture, the horizontal axis is the wavelength, the vertical axis is the energy, the blue line is the original light, and the red line is the soil absorbed light. as shown in Figure (5)

- b. The water content of the soil before and after the drying is not significantly reduced, and the long-wave band of reflected light is less absorbed after the drying, especially at the location of the Anyi Road police station (A2). The difference in absorption of the topsoil before and after drying on the slopes in the school is small, and two places are more viscous to the touch.

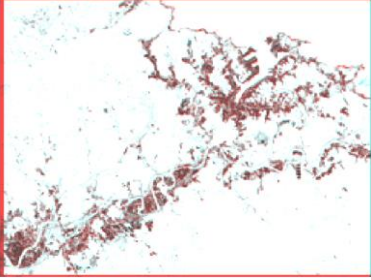
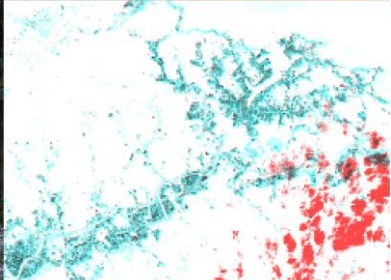
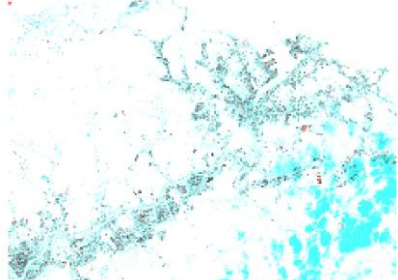
The red light and near-infrared light are converted into various vegetation indexes to monitor the ground vegetation. Its method of monitoring the temporal and spatial changes of vegetation biophysical characteristics is the most widely used vegetation identification and migration change. Therefore, we use this method to look at the four sentinel images of 20190131, 20190312, 20191117, and 20191217, and do the analysis of the changes in the images before and after.

<p><b>Figure (6)</b>, 20190131 and 20190312NDVI add up.</p>	<p><b>Figure (7)</b>, 20190312 and 20191117NDVI add up.</p>	<p><b>Figure (8)</b>, 20191117 and 20191217NDVI add up.</p>

- c. The NDVI obtained by using satellite spectral calculations can also be used as one of the conditions for judging collapsed land by the growth and decline of vegetation. If the reflected light can be added to see the characteristics of the surface soil spectrum, I believe that the grasp of the collapsed land can be more accurate.
