The Persistence of a Liquid Puddle when the Air Temperature is Below Freezing

Peggy LeMone
Jefferson Junior High School
Columbia, Missouri

Teacher: Mrs. Spragg
23 April 2008

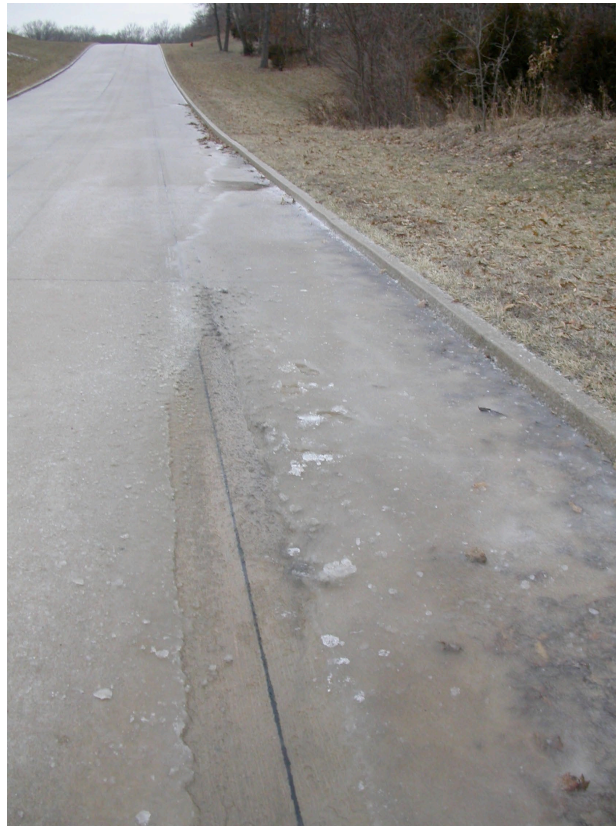
Figure 1. Picture of puddle on road in Columbia, Missouri, USA, on 21 February 2008.

This study was prompted by the surprising discovery of a liquid puddle on a residential road, after several days of subfreezing temperatures (-7°C and below, see Figure 1) and no precipitation. Where did the water come from? Why wasn't it frozen?

Shortly after the picture in Figure 1 was taken, it started to snow. A few hours later, I noticed crystals on the road, each surrounded by melting snow (Figure 6), and I saw the truck spreading the crystals. I picked up a crystal and carefully tasted it, verifying that it was in fact sodium chloride (table salt). When I visited the dried-out puddle site in March, I noticed white

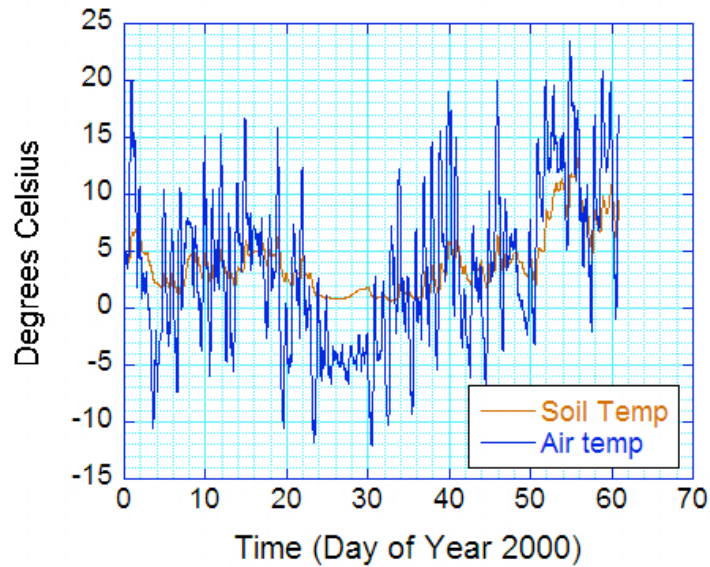
Figure 4. For grassland site near Smileyberg, Kansas, the air temperature (at about 2 meters) and soil temperature (average 0-5 cm). Data from Argonne National Laboratory, courtesy R.E. Coulter.

Figures 3 and 4 show examples of temperature changes with depth during periods in the winter when the air temperature reaches its lowest values. These are periods similar to when the puddle was first observed.

In both cases, the soil temperature stayed warmer than the air temperature. Further, we see from Figure 3 that the soil temperature is warmer with greater depth, as expected. Thus it is likely that there could be unfrozen water below the surface.

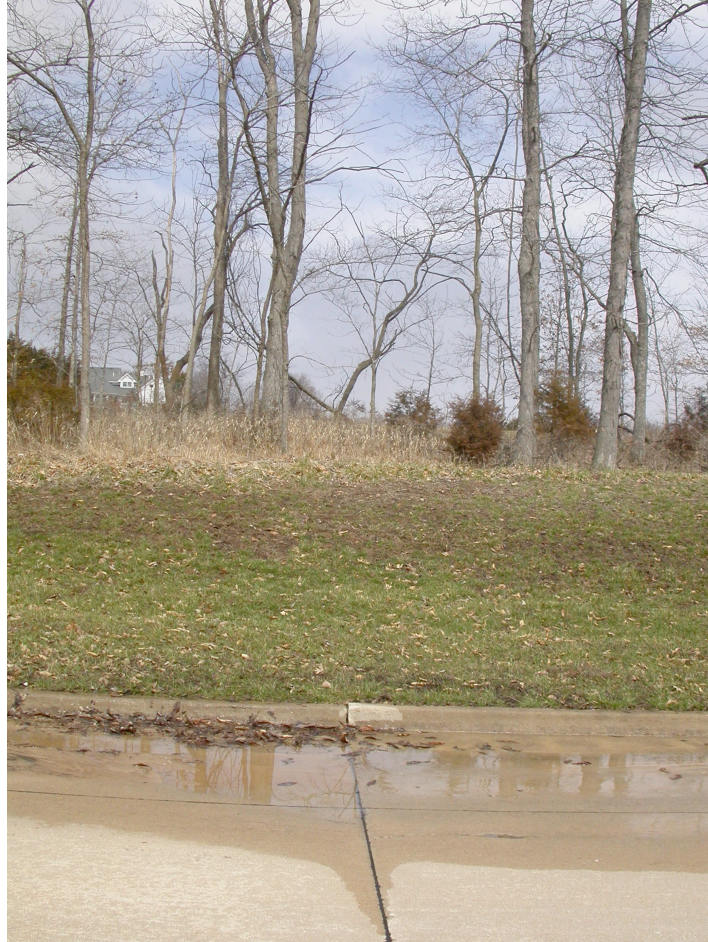
Figure 5. Puddle site, photographed in March, showing a gap in the curb and water seeping up through a crack in the road.

To see whether there were places groundwater that were leaking onto the road, we visited the puddle site and photographed the street (Figure 5). From the figure, we see a gap in the curb (15-20 centimeters high), and water is clearly seeping up through a gap in the road. Most of the gap is sealed with tar, but there are clearly openings for the water to seep through.

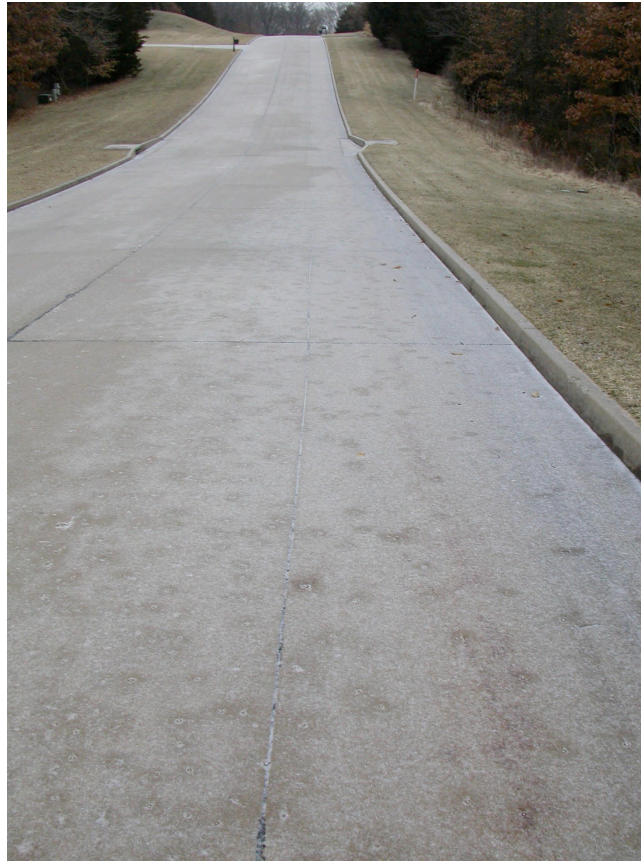
Figure 6. Snow melting around salt crystals
