Miina Härma Gymnasium

**Artificial Lakes as Sources of Pollution:
the Example of Haage and Ropka Water Reservoirs**

GLOBE program student report

Tartu 2018

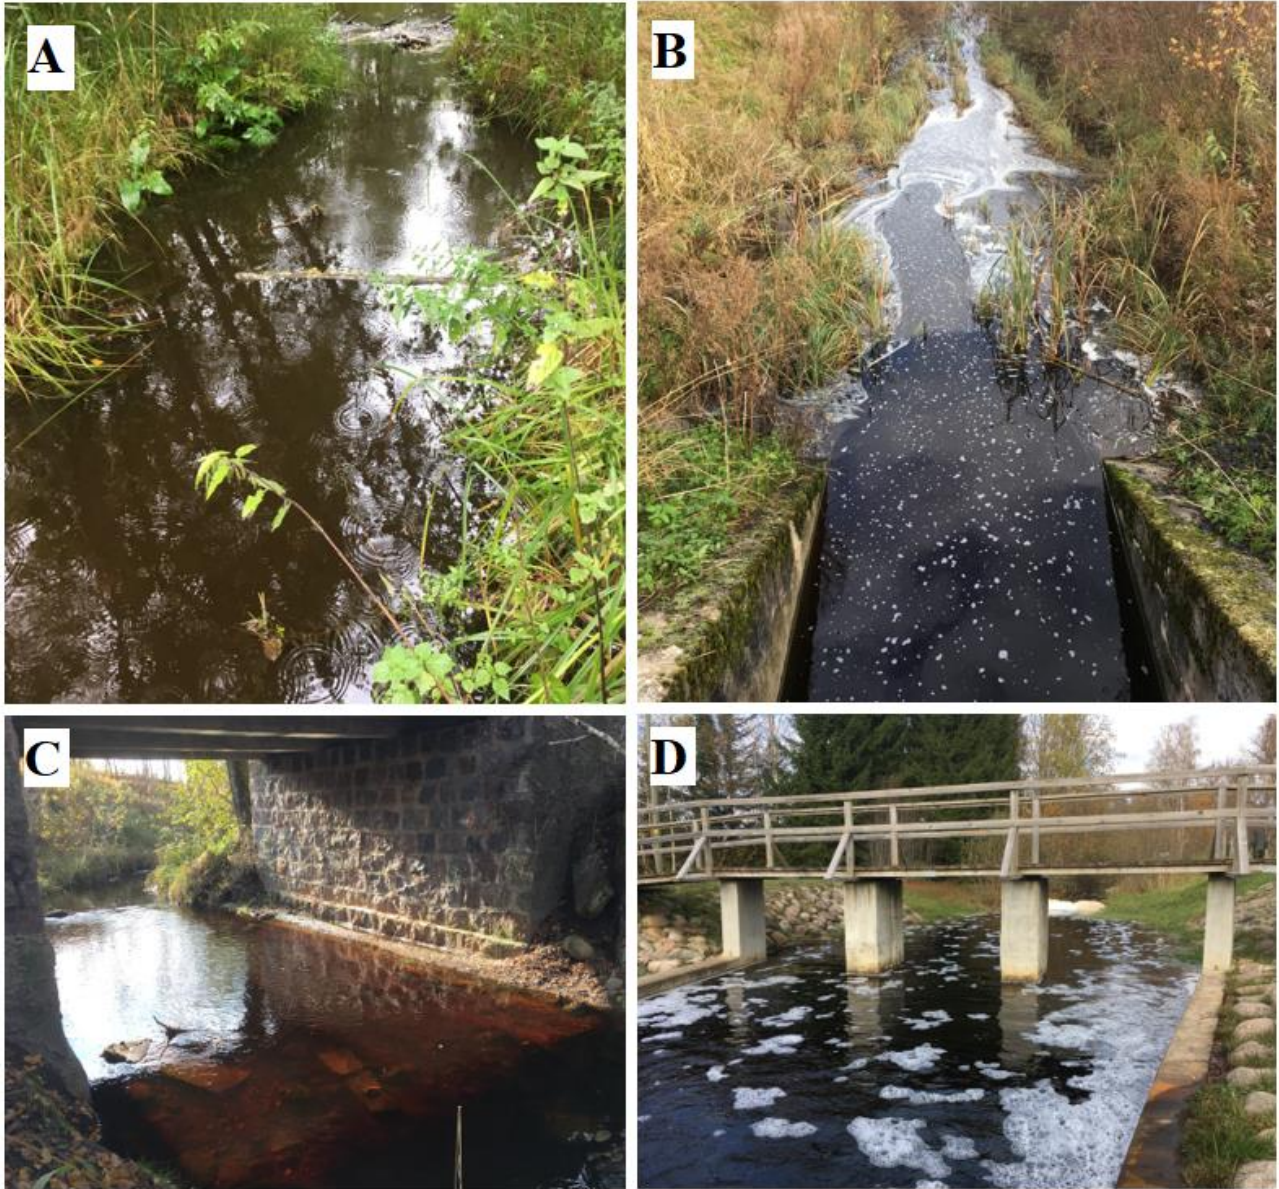
Figure 3. In- and outflows of Haage and Ropka reservoirs. A – inflow of Haage reservoir; B – outflow of Haage reservoir; C – inflow of Ropka reservoir; D – outflow of Ropka reservoir. Photos by R. Laarmaa, taken 15.09.2017 (A) and 22.10.2017 (B, C and D).

The in- and outflows varied greatly in terms of the surrounding landscape and features (figure 3). In lake Haage, the inflow (figures 2 and 3A) was about 200 meters inside forest with very muddy ground at some places (figure 4). The stream appeared not to be used regularly, as there were no signs of human activity. The outflow of the same reservoir was directly next to a road with moderate amount of traffic and there was a small parking place about 50 meters from the dam (figures 2 and 3B).

The measuring site for the inflow of lake Ropka was directly under the bridge on the outskirts of the settlement (figures 2 and 3C). The outflow was also next to a road, in the middle of the settlement, with residences nearby in all directions (figures 2 and 3D). It also had a bridge for pedestrian use. On the days of probing, a house was under construction about 50 meters from the outflow.

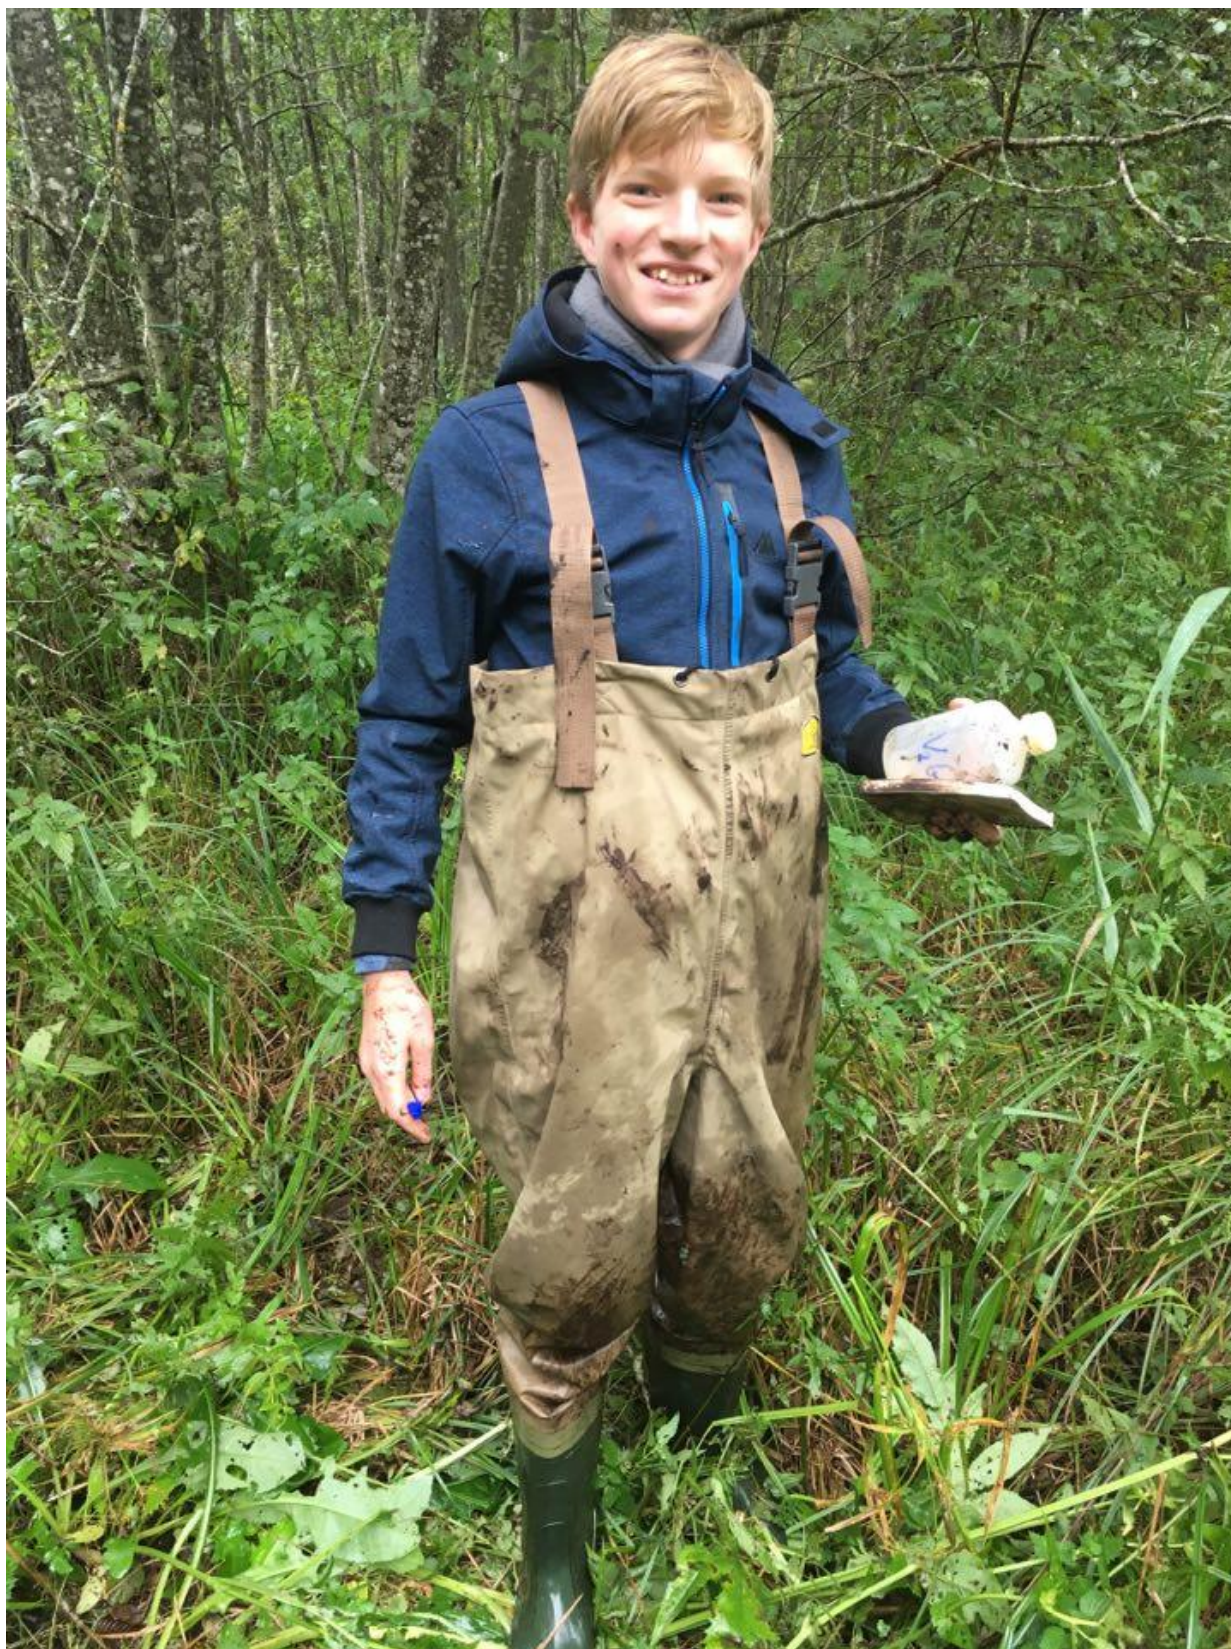
Figure 4. Collecting water samples near the inflow of Haage reservoir, where the ground is not stable. Author after arrival to the measuring site on September 15th, 2017 (photo: R. Laarmaa).

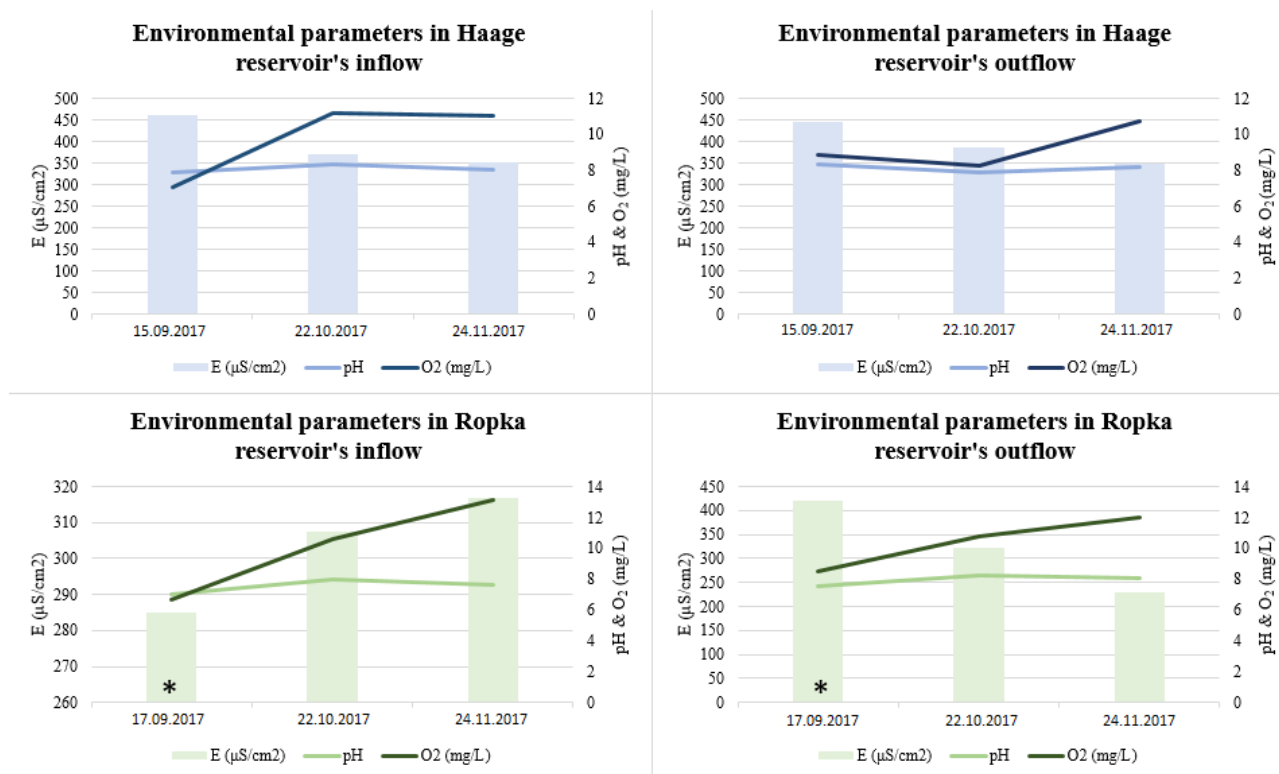
Figure 5. Some environmental parameters in Haage (blue) and Ropka (green) reservoirs 15.09.2017 – 24.11.2017. * There were technical problems with the multisensor, therefore pH values that are reported in 17.09.2017 are measured with the AQUANAL™-Oekotest Water Laboratory.

Dynamics of some environmental parameters measured by multimeter probe YSI Pro Plus 6600, such as conductivity (E, $\mu\text{S}/\text{cm}^2$), pH and oxygen concentration (O_2 , mg/L), are shown in figure 5.

These results (conductivity and pH) indicate that the water in the reservoirs can be described as quite hard and therefore the reservoirs are quite tolerant ecosystems. Oxygen conditions indicate the good quality of the water ecosystem.
