Kaelepulu Canal Water Quality Testing: A GLOBE-Inspired Scientific Inquiry

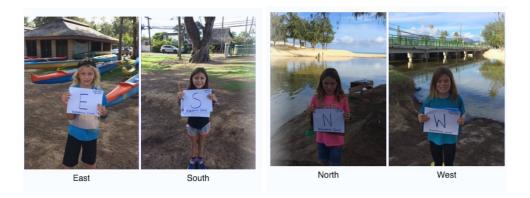
Site Information	
Site ID	45920
Name	Kaelepulu Canal (Eastern Bank)
Latitude	21.39636°
Longitude	-157.72641°
Elevation	4.8m
Location Source	gps

Water Body Name	Kaelepulu Canal
Water Body Type	brackish
Water Body Source	pond
Area	0.574654 sq/km
Depth	1.5 m
Water Sample Location	bank
Can See Bottom	Yes
Bank Material	Unknown
Bedrock Type	Mixed Sediments
Salt Habitat	has Sandy Shore
