How healthy is our Local Deansgrange River?

Citizen Science @ Rockford Manor

By Ananya, Eve and Sarah

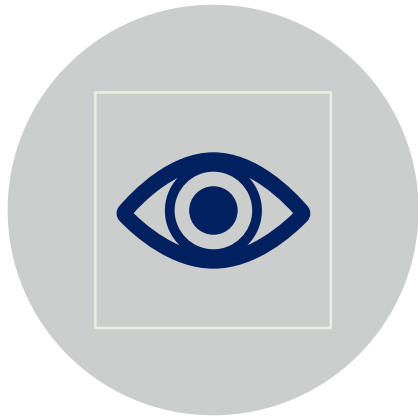
VISUAL INSPECTION

Students took time to walk quietly along the river to observe and record the following details in their worksheets.

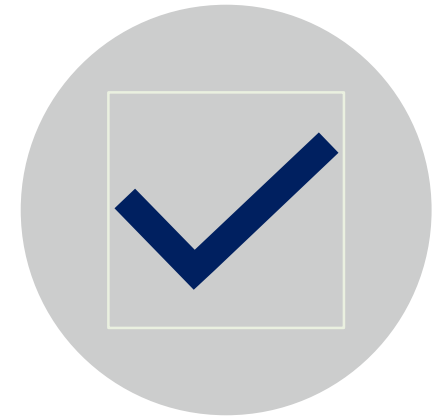
KICK SAMPLE

Kick sample testing was carried out on the riverbed to investigate the species of freshwater invertebrates present.

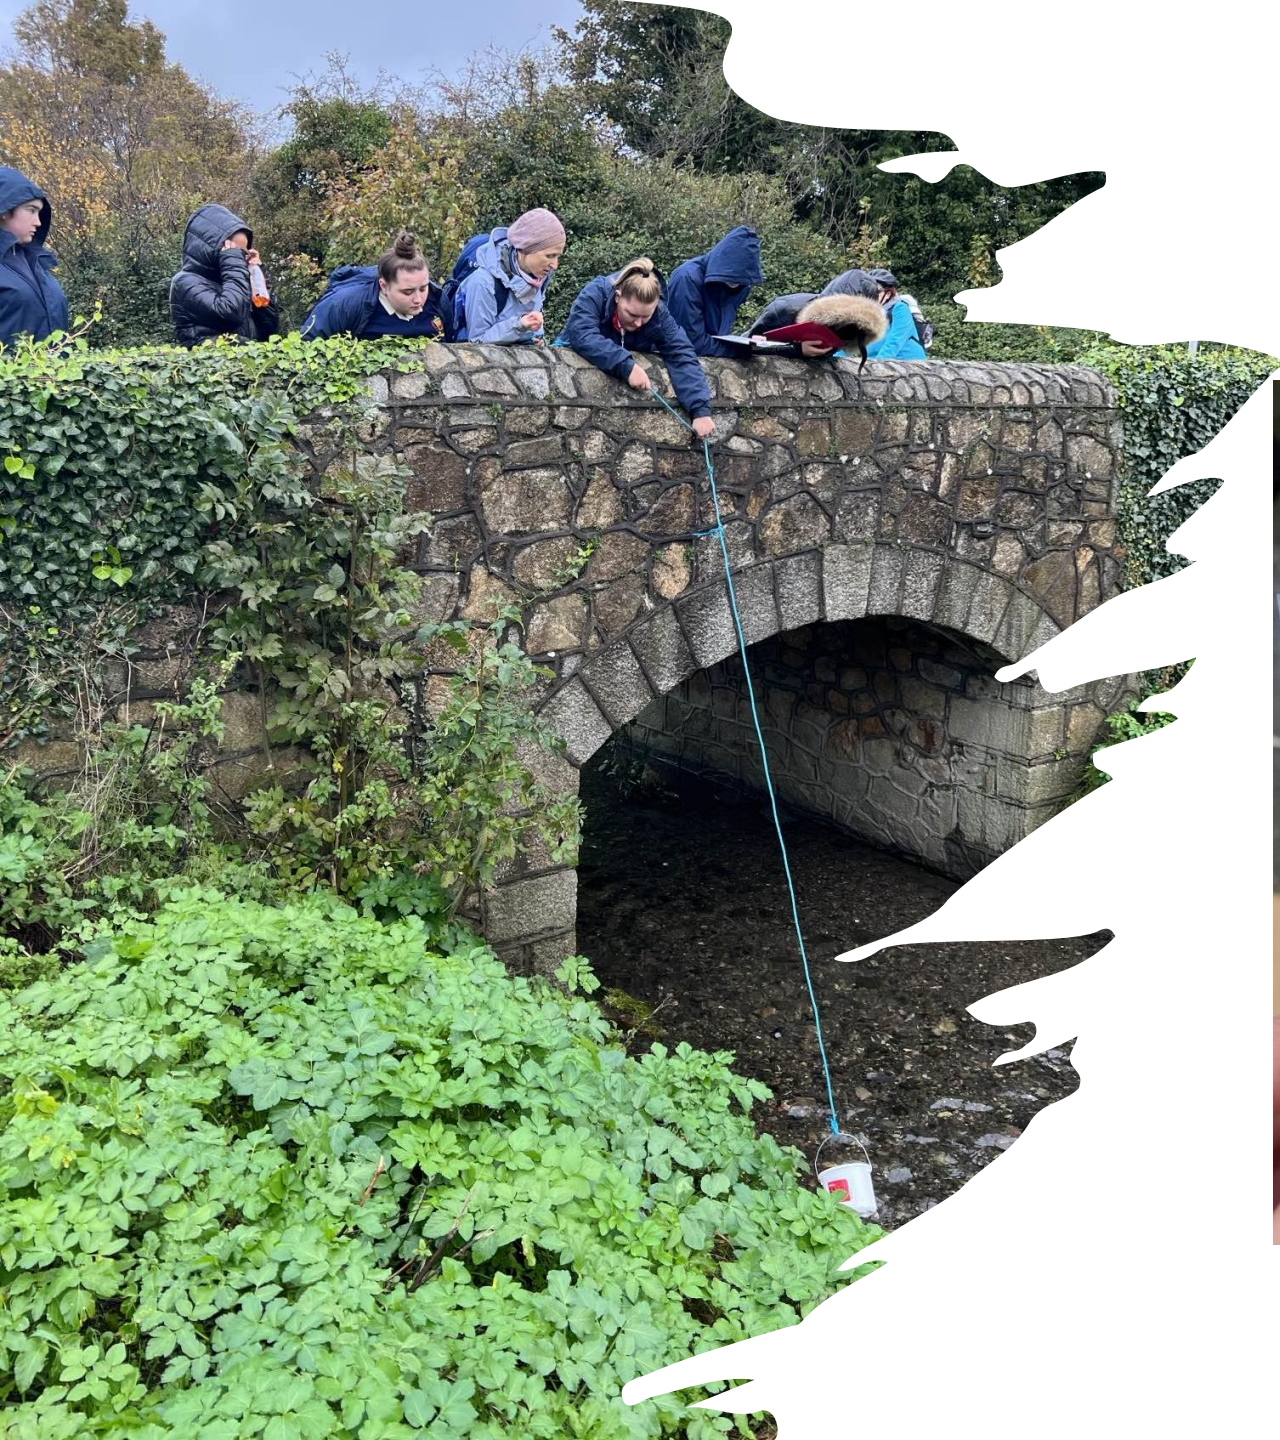
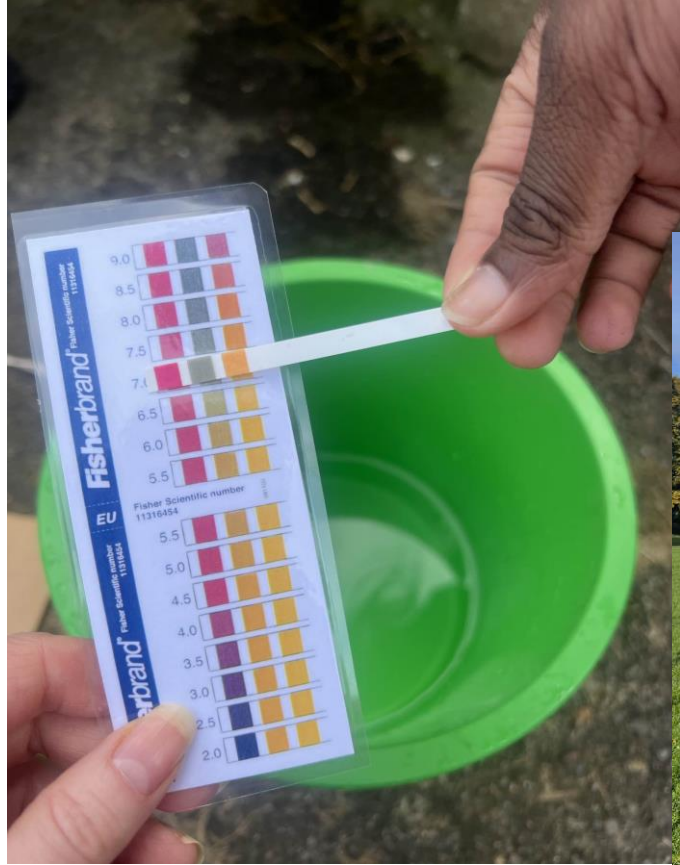
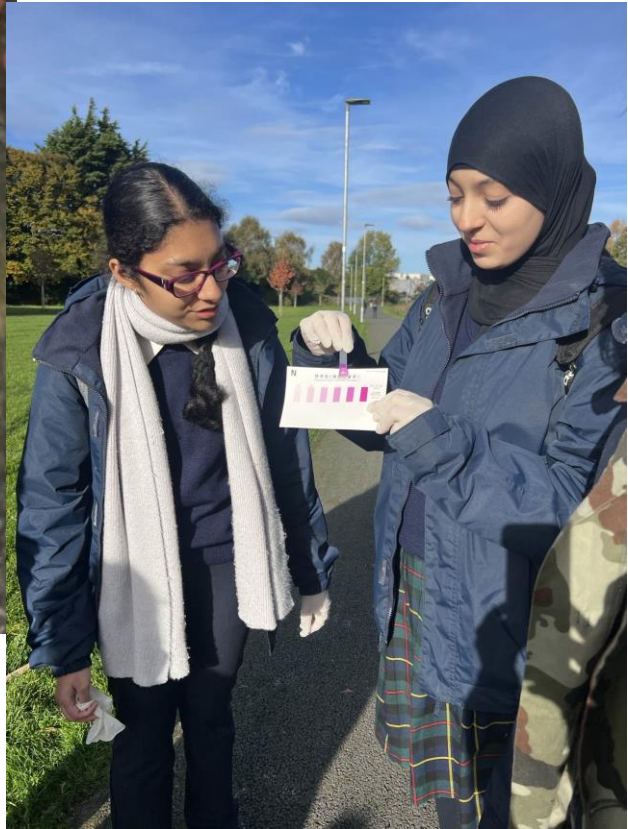
Chemical tests

Nitrate and phosphate test kits were used along with comparator color charts to determine nutrient concentrations.

pH	Color
9.0	Light pink
8.5	Pink
8.0	Light red
7.5	Red
7.0	Dark red
6.5	Orange-red
6.0	Orange
5.5	Yellow-orange
5.0	Yellow
4.5	Light green
4.0	Green
3.5	Light blue
3.0	Blue
2.5	Dark blue
2.0	Very dark blue

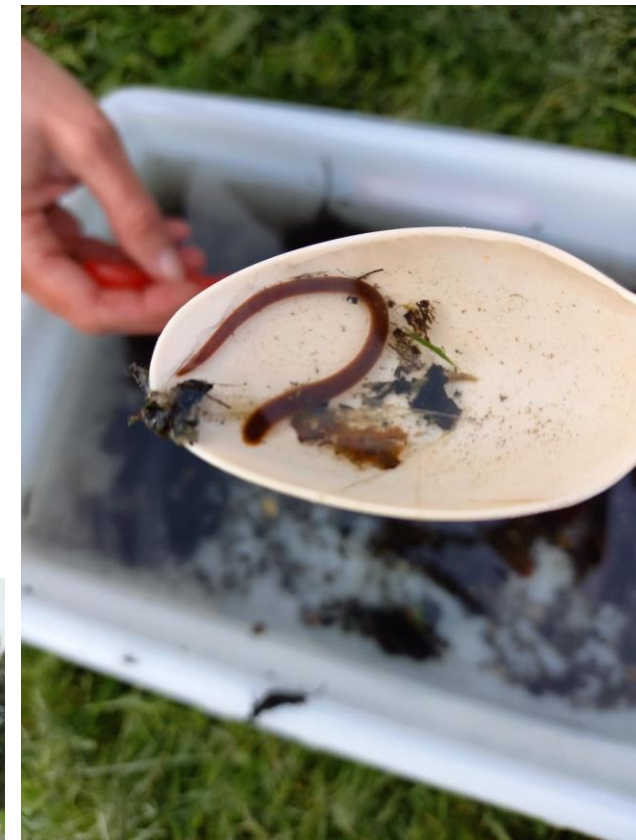
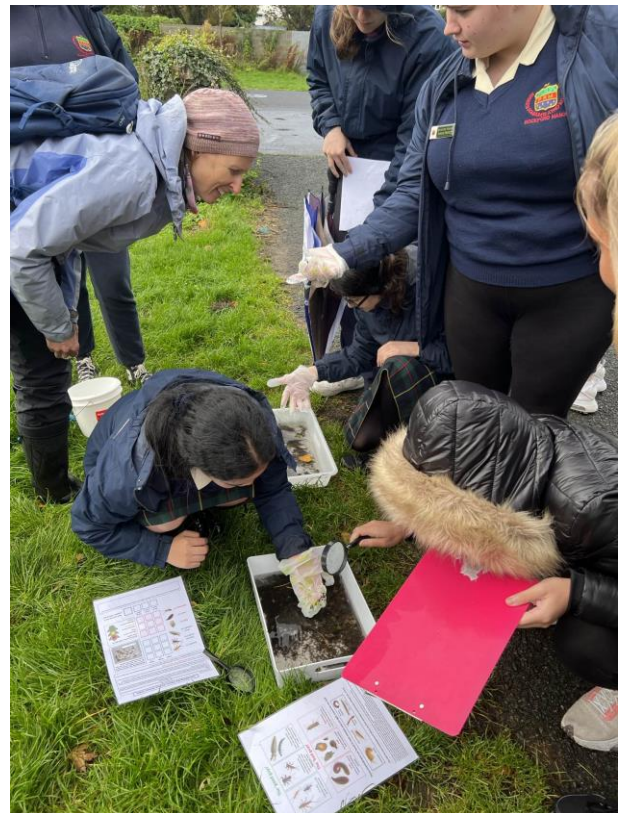
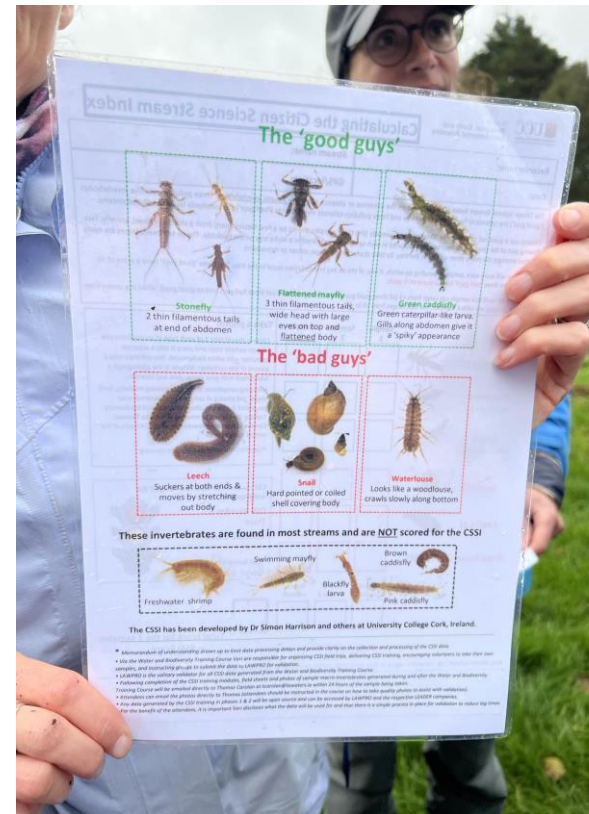
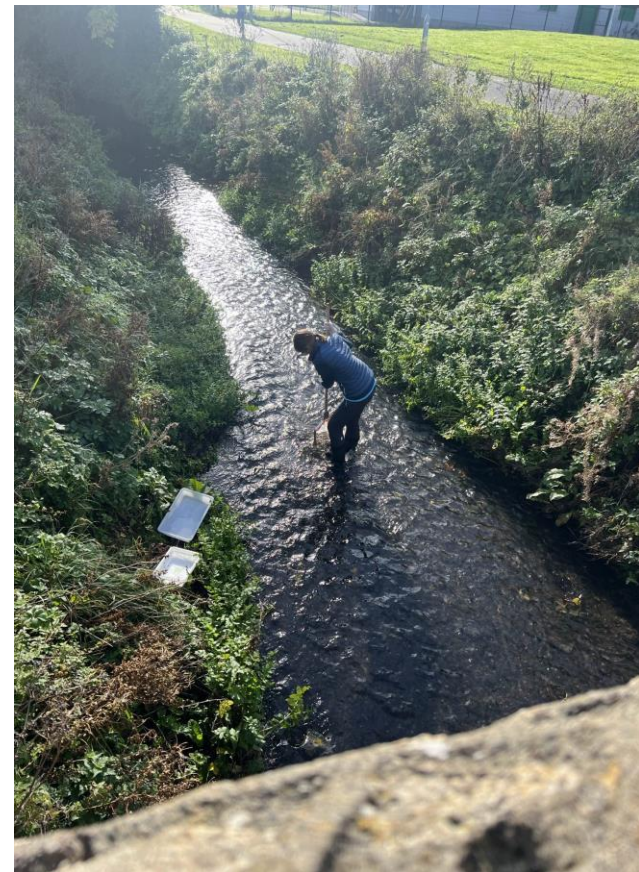
Kick Sample Testing

Identification keys were used to name any creatures found.

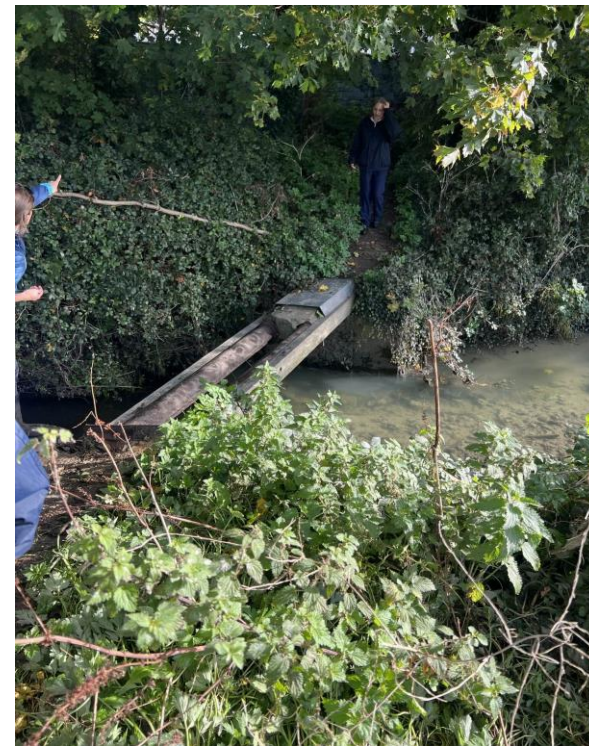
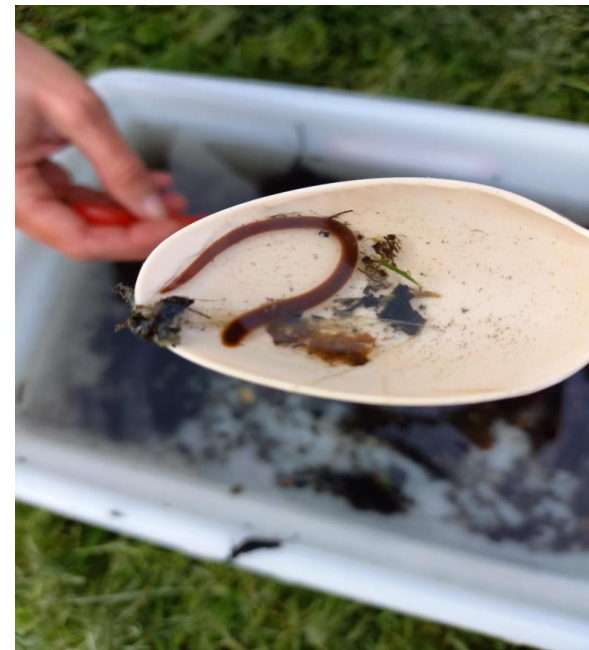
Visual inspection: The water was mostly clear, but some litter was found in and around the river. Some effluent in the water from a pipe, making the water cloudy in one location.

River Water Quality tests: indicated high levels of nitrates and acceptable levels of phosphates in the water.

Kick sampling tests: indicated high amounts of pollutant tolerant species such as freshwater shrimp, leeches, water snails and water lice. Pollutant sensitive species such as green caddisfly and stoneflies were absent.

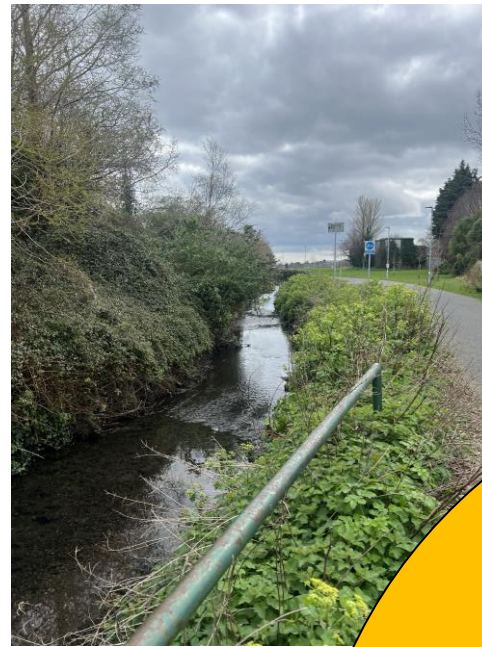
Results summary

Nitrate concentration ppm	Phosphate concentration ppm	pH	Water Temp °C
2 - 5	0.05 – 0.1	7	12

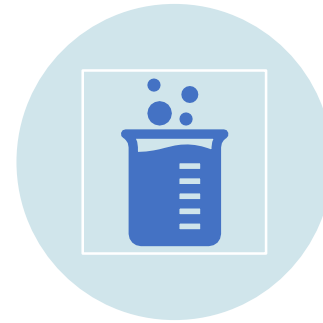
Elevated nitrate levels may be due to fertilizers entering the water upstream.

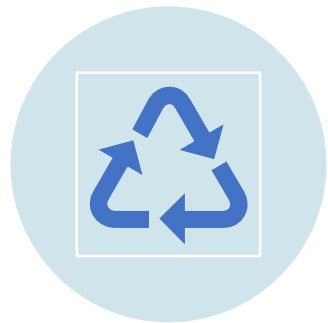
The presence of rubbish in the water and the mystery effluent entering the water could also indicate poor river health.

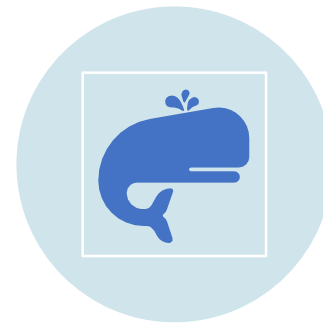
Another concerning finding of our studies is the absence of pollution-sensitive invertebrates such as green caddisfly, stonefly and flattened mayfly. Their presence would indicate good water quality. The presence of pollution tolerant invertebrates such as leeches and snails further indicates poor water quality.
